OREGON CORNER RESTORATION FORM

Township 1 North Range 7 West Sections 4 & 9

County: Tillamook Date: 7-25-1997

Corner Designation: E 1/16 Corner 4/9 X Condition Report Only

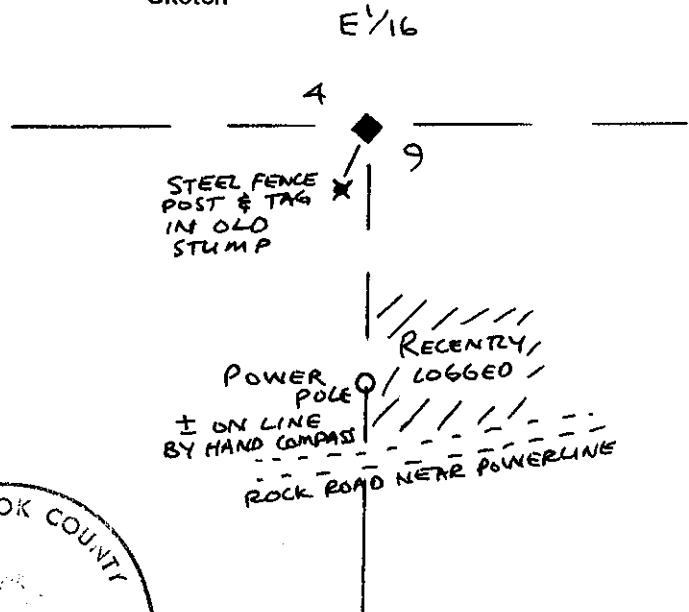
Sketch

Monument Found (Condition and Source) : Found 3" brass cap on 2"o.d. galvanized iron pipe, flush with ground surface, marked as shown below. A green steel fencepost is near the Northeast edge of the cap.

Accessories Found: Found green steel fencepost with yellow OSBF (Oregon State Board of Forestry) BT tag marked "E 1/16 = 17.6 N17E D D Davis 5-24-51 199". This fencepost is in a decayed stump, and is roughly 18 feet S17W from the brass cap.
 Note: Oregon LS#199 = Lyle Beyers

Location & Comments: Corner falls about halfway up a steep south-facing slope, roughly four hundred feet north of a rocked road running E-W under a powerline. A power pole on the north side of that powerline road is approximately South of this corner. The corner is in a stand of second growth Douglas-fir, with 2 fairly recently windthrown firs about 35 feet west of the corner. The firs near the powerline road have been cut on the east side of a line run South from the corner.
