OREGON PUBLIC LAND CORNER REPORT / RESTORATION REPORT
Tillamook County Surveyor's Office

SECTION: SW Section 11	TOWNSHIP 1 South	RANGE 9 West
COUNTY: Tillamook		DATE: 3-19-13
CORNER DESIGNATION: The Section Corner common to Sections 11 and 14 only, T. 1 S., R. 9 W., W.M.		(Please check one)
		<input type="checkbox"/> Condition Report Only
		<input type="checkbox"/> Restoration
		<input checked="" type="checkbox"/> Rewitness
		<input type="checkbox"/> Unrecorded
		<input type="checkbox"/> Reset at surface
		<input type="checkbox"/> Referenced Out
Previous Rewitnesses, Restorations and Surveys, etc: BLM Field Notes Volume: OR-R0575 Page 217 (1958), Map A-1100 (1963), Map B-530 (1960-1967), Map A-2687 (1974), Tillamook County Survey Records.		
Found Monument(s) and Accessories (Condition & Source): Original Corner was set by GLO in 1857 as the Section Corner common to Sections 10, 11, 14 and 15. In 1884, GLO performed an independent survey of the remaining unsurveyed T. 1 S., R. 9 W., where it was determined that the corner of Sections 10 and 15 were not in common with the corner of Sections 11 and 14 and set a Closing Corner at this position. This monument was found and confirmed in

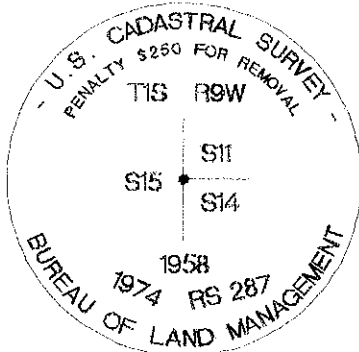
Found 3" dia. Bureau of Land Management Brass Cap marked as shown hereon, up 1.0', on southerly side of a rotten hemlock stump. Monument is on the edge of a steep slide to the east. Found steel "T" post lying down.		
(GLO 1884) – Did not find the (5" Fir bearing S47° E 84 lks. [55.44']).		
(GLO 1884) – Did not find the (4" Fir bearing N 61°30' E 65 lks. [42.90']).		
(BLM 1958) – Did not find the (27" Hemlock bearing N 64°30' E 20.5 lks. [13.53']).		
(BLM 1958) – Did not find the (37" Fir bearing S 56°30' E 67 lks. [44.22']).		
() Indicates record information, Tillamook County Survey Records.		
[] Indicates record links converted to feet.		
Monument Set (Procedures and Description): N/A		Sketch of Found Monument:

New Accessories set: Set 60 lbs. of concrete in a 12" dia. cylinder around monument. Set a 72" hat section post with a yellow metal location tag 3.0' North of the monument. Re-set found steel "T" post 3.0' South of the monument.
