OREGON PUBLIC LAND CORNER REPORT / RESTORATION REPORT
Tillamook County Surveyor's Office

SECTION: 18	TOWNSHIP: 1 South	RANGE: 9 West
COUNTY: Tillamook		DATE: 02/2022
CORNER DESIGNATION: Section Corner Common to Sections 17, 18, 19 and 20, 1 South, 9 West, Willamette Meridian.		(Please check one)
		<input type="checkbox"/> Condition Report Only
		<input type="checkbox"/> Restoration
		<input checked="" type="checkbox"/> Rewitness
		<input type="checkbox"/> Unrecorded
		<input type="checkbox"/> Reset at surface
		<input type="checkbox"/> Referenced Out

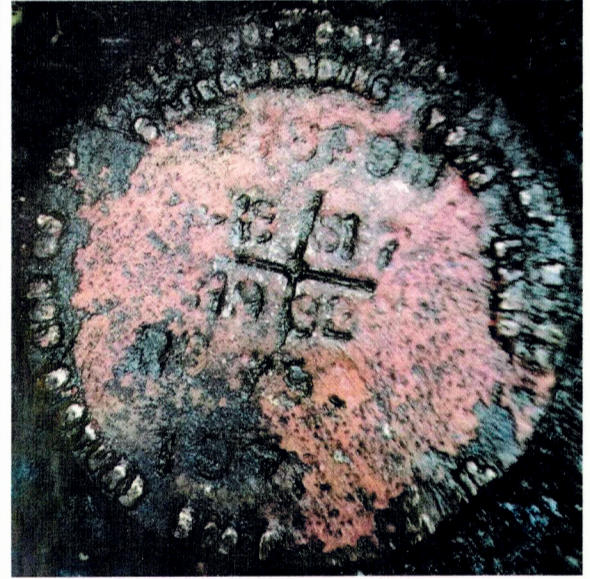
Pictures of Found Monuments:

In 1857 the Section corner was monumented by a wood post by the General land Survey Office from which 4 accessories were set. In 1887 (Rewitness bk. 10 pg. 5-6) R. R. Hayes renews corner to section by setting post for corner from which he sets 4 accessories. In 1949 (Rewitness bk. 4 pg. 54) W. E. Anderson set 4 new accessories for the section corner. In 1955 (A-612) W.E. Anderson either found or set 3" iron pipe for corner. In 1960 (A-853) M.H. Easton found 3" Iron pipe for the section corner. In 1966 Alan E. Duncan (Rewitness card 206) set a hex bar for the corner inside a found 2.5" Iron Pipe. In 1973 The Tillamook County Surveyors office (Rewitness card # 206) set a 2" Iron pipe with a 3" Tillamook County Brass cap over the top of the 1" hex bar in 10" tile and concrete stamped as shown hereon. In 2021 Tillamook County Surveyors office found the section corner as shown hereon, no accessories to the corner were found.

Set: 84" hat section post with yellow metal location tag 1.3' North.
Found: P. P. & L. transmission line pole South 32° East 8.4' to face of pole
Found: P. P. & L. transmission line pole South 40° West 12' to face of pole
