OREGON PUBLIC LAND CORNER REPORT / RESTORATION REPORT
Tillamook County Surveyor's Office

SECTION: 29 & 30 TOWNSHIP: 3 South RANGE: 9 West

CORNER DESIGNATION: South Sixteenth corner of Sections 29 and 30, Township 3 South, Range 9 West; Willamette Meridian.	(Please check one)	
	<input type="checkbox"/>	Condition Report Only
	<input type="checkbox"/>	Restoration
	<input type="checkbox"/>	Rewitness
	<input type="checkbox"/>	Unrecorded
	<input checked="" type="checkbox"/>	Reset at surface
<input type="checkbox"/>	Referenced Out

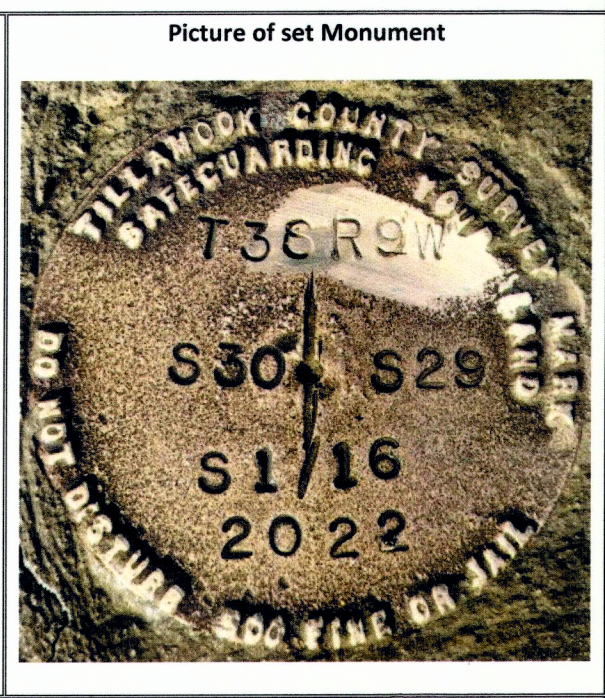
History, condition, and sources: The monument for the South 1/16th corner of Sections 29 and 30 was first set by U. G. Jackson (F40-56) in 1913. He set a galvanized iron pipe for the monument. In 1959 (A-823) The sixteenth corner was reported to be a pipe. There is no description of the corner recorded from 1959 until 1966 (Rewitness Bk. 5 pg. 212) the Tillamook County Surveyors office found a 3/4" iron bar flush with blacktop and they set 4 new accessories. In 1971 (Rewitness # 555) The Tillamook County Surveyors office found the iron bar and placed 1.25" rebar with centerpunch over existing found iron bar no new accessories were set. In 2015 the Tillamook County Surveyors office found 1.25" centerpunched rebar .30' below surface of the road and set one new accessory. In 2021 Tillamook County Surveyors office had the Tillamook County public works install 6" metal sleeve while paving around the found South 1/16th corner a centerpunched 1.25" rebar .6' below surface and added a 3" Tillamook County Brass cap with 1.25" rebar stem over the existing monument anchored in concrete and stamped as shown hereon.

Location: ±367' East from the intersection of Hwy 101 and Beaver-Blaine Rd. and ±5.5' North of painted centerline of Beaver-Blaine Rd.

New : Set a 3" Tillamook County Brass Cap with a 6" long by 1.25" rebar stem in a 6" metal sleeve with anchoring cement flush with the surface of the pavement stamped as shown hereon. The new monument was set over the found 1.25" center punched rebar using a tripod with a laser plumet attached; set up directly over the old monument and centered on the dimple of the existing monument. Anchoring cement was then mixed up and the monument was set in the concrete and aligned using the laser plumet. Position was verified by performing a direct static GPS tie.
