## Neskowin Coastal Hazard Area Permit #851-24-000098-PLNG: Wombwell/Alfonso

### NOTICE OF ADMINISTRATIVE REVIEW Date of Notice: October 14, 2024

**#851-24-000098-PLNG:** A request for approval of a Neskowin Coastal Hazard Area Permit for the removal of a tree, on a property located within the Unincorporated Community Boundary of Neskowin, zoned Neskowin Low Density Residential (NeskR-1) and within the Neskowin Coastal Hazards Overlay (Nesk-CH) Zone. The subject property is accessed via South Beach Road and designated as Tax Lot 4800 of Section 35DA in Township 5 South, Range 11 West of the Willamette Meridian, Tillamook County, Oregon. The applicant is Adam Alfonso and the property owner is Daen Wombwell and Grace Barnard.

Request: Dangerous tree Removal w/n Coastal Hazard Overlay  
line

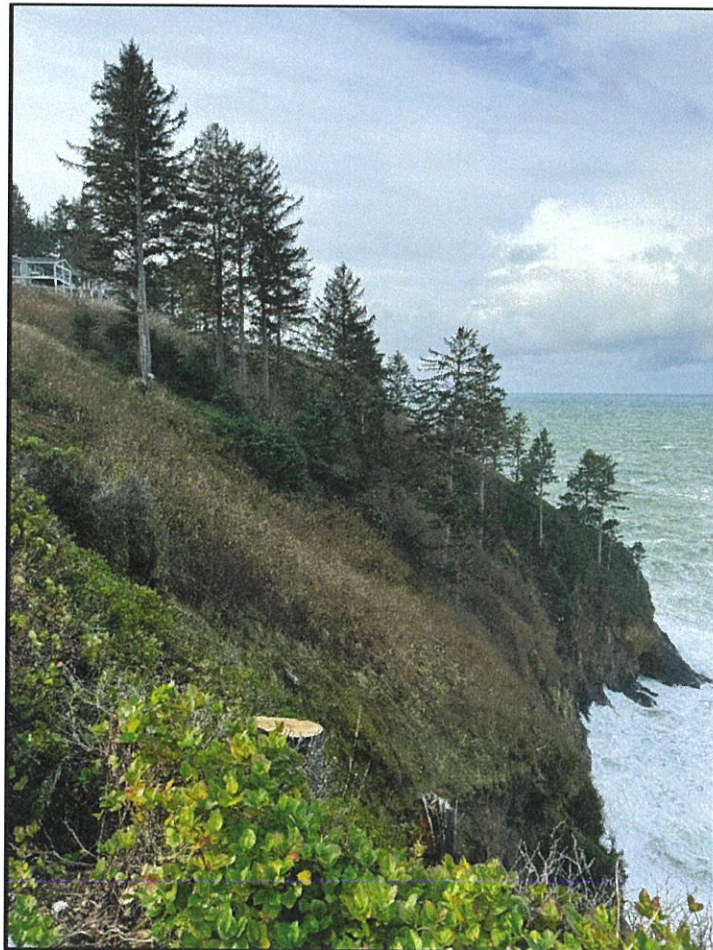
1. Based on the areas that we could observe, there did not appear to have been any areas of substantial recent erosion on the property, and there were no apparent signs of slope instability on the parcel where the tree was removed (Photo 1). The slope generally lacked any mature trees and appears to be composed of weathered bedrock and colluvium and was generally well-drained, dense and rocky.
2. The Arborist report prepared by David D. Hunter noted that the tree before removal was observed to have a 10 percent trunk lean due to the canopy being top heavy (limb dieback) to the east in the direction of the residence currently under construction. Additionally, the tree was observed to have brown butt rot and the stump base was swollen as further evidence of root disease. The arborist also noted that areas nearby have a known history of brown butt rot failures.

**Photo 1:** View of the stump of the removed Sitka spruce. View is looking south toward the Pacific Ocean.

It should be noted that the stump could be flush cut at the ground surface, but we recommend that under no circumstances should the subsurface portion of stumps or root mass be removed. We also recommend replacing the removed tree with new vegetation. In terms of vegetation on slopes, we generally recommend all invasive vegetation (such as Scotch Broom, English ivy and Himalayan blackberry) is removed where encountered on the slope and (where possible) that deep-rooted species of native or “native allies” trees and shrubs are densely planted on the slope. Irrigation may be necessary while the root systems become established, especially through the dry summer months. Once established, vegetation usually requires little to no maintenance and little to no irrigation. We generally recommend new trees and shrubs are spaced roughly 3 to 5 feet apart; however, an arborist and landscape designer should be contacted for specific re-planting recommendations and to guarantee successful revegetation of the removed tree.

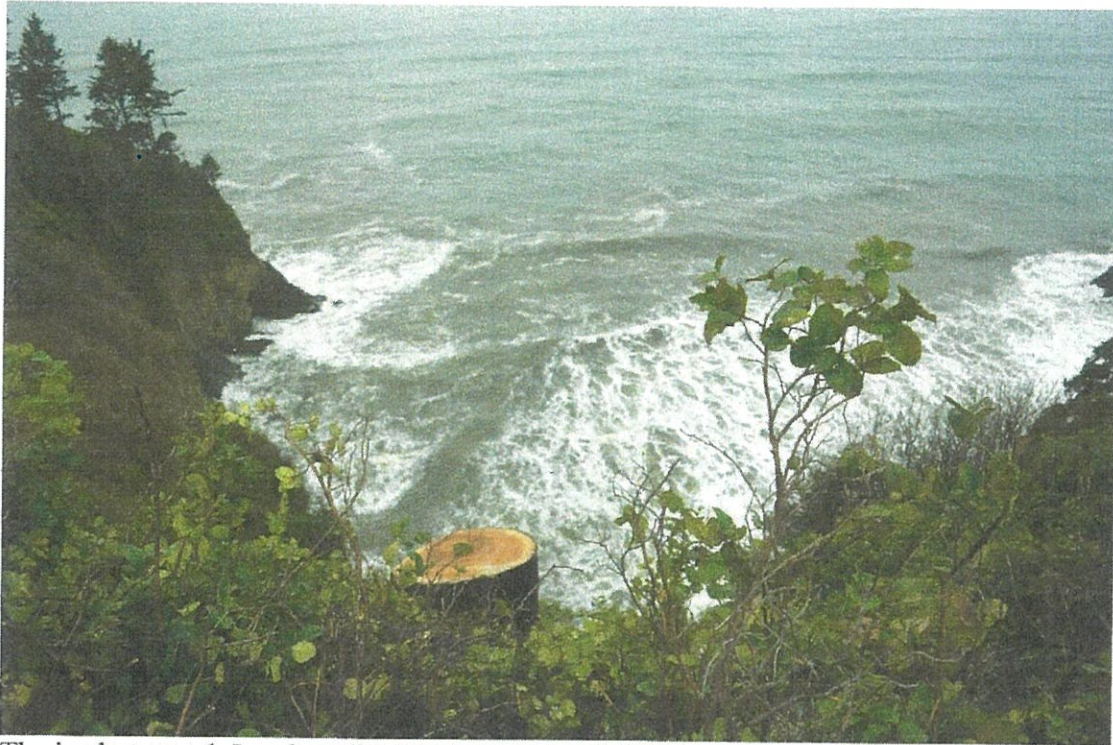
The is photograph I took on December 11, 2023 from the fence line edge looking over the edge at the tree stump. Stump is 20' down slope. To right is open space where tree was prior but failed and took surrounding soil and tree to ocean. The stump at least remains and will hold the soil and slope for many years till the roots rot out.

Looking at the stump the center and to the left of the salal leaf the stump wood is off-colored and darker color which is a sign of brown butt rot. The stump base was also swollen as another sign to the root disease.

I discussed with the tree service Klint Venti what was found in the tree during the removal. The tree had a hard top lean to the east, tip /limb dieback (sign of root disease), decay in the stems cutting in the upper part of the tree, and water cavities where hollows in upper areas allowed water to be stored.

I recommend that the stump remain in place to help hold the steep cliff area. If new trees seed in, I recommend allowing them to grow and hold the soil and slope.

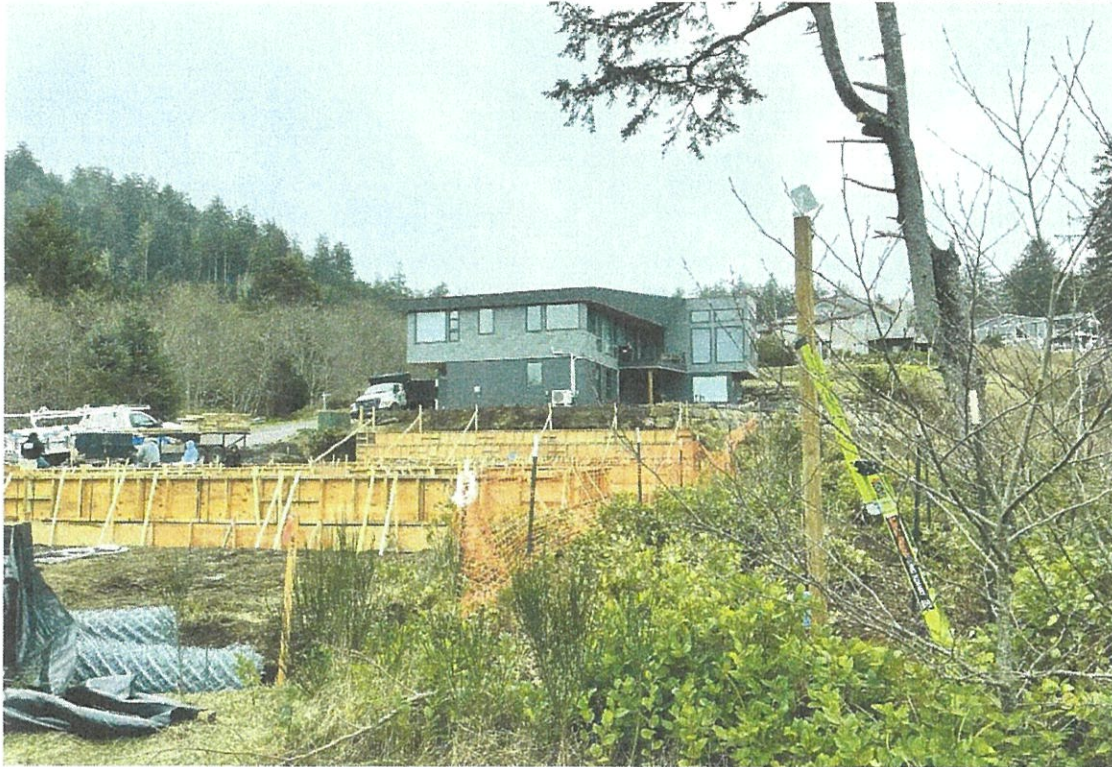
View of the tree from the north, trunk lean is east, limb weight is east. Had to have been other trees to the west that failed and are no longer there.

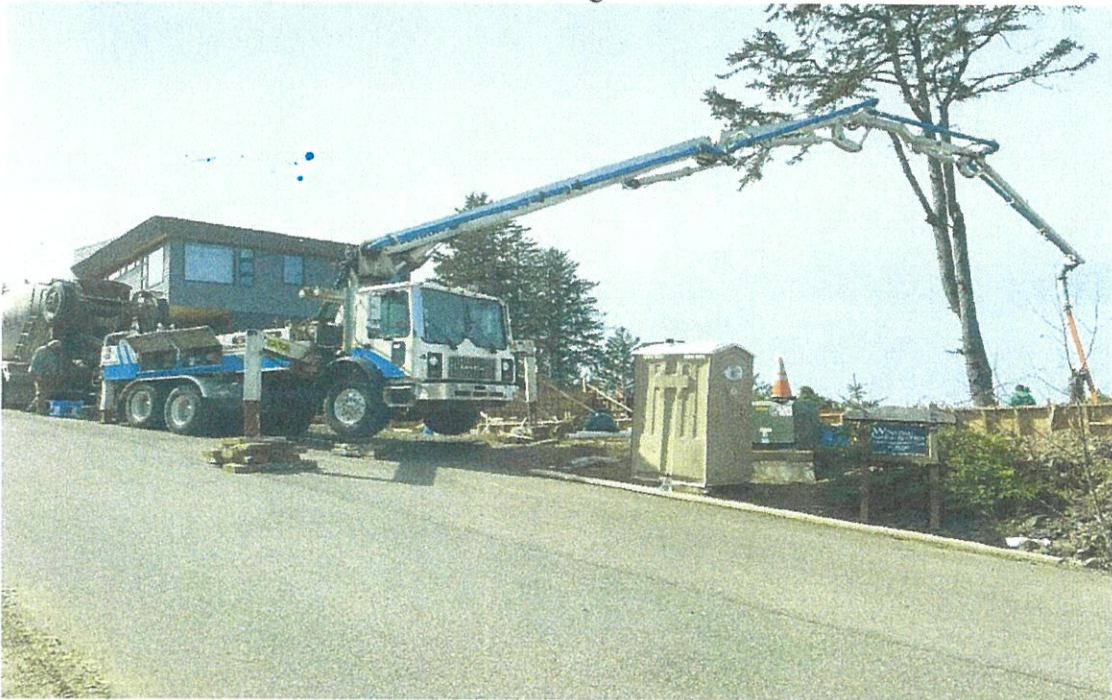
View of the tree from road trunk lean, limb dieback, crown top heavy.

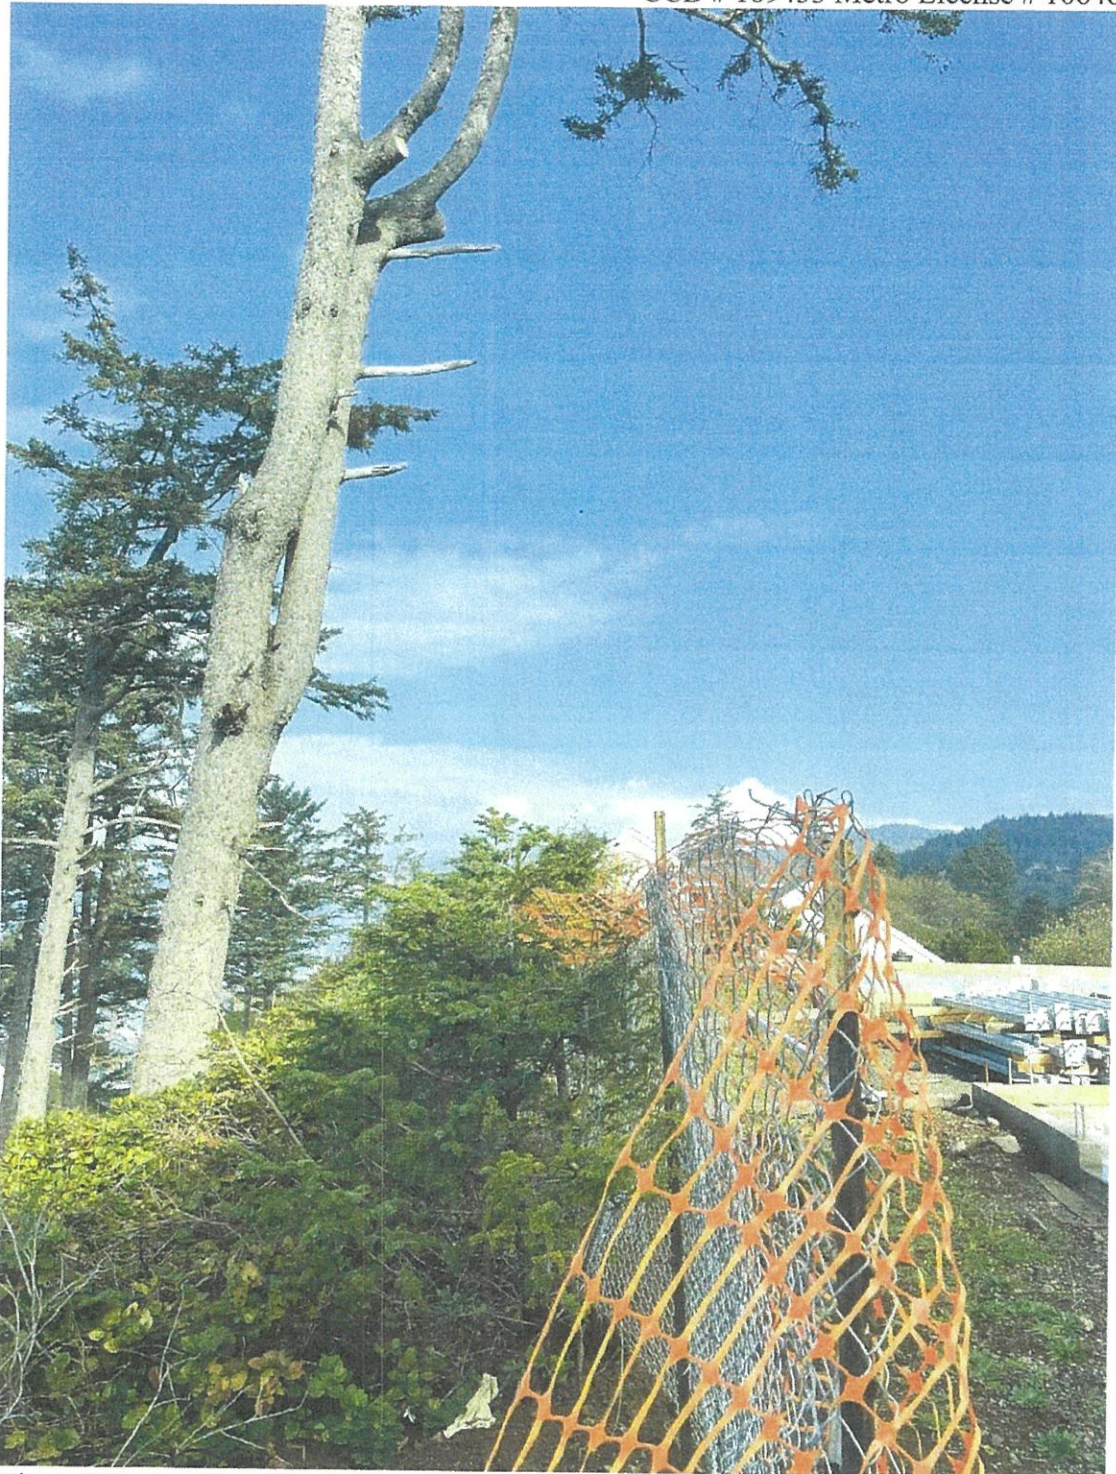
View of the tree from the south trunk lean 10 percent, prior defect left stem mid stem left with the white knob on the left.

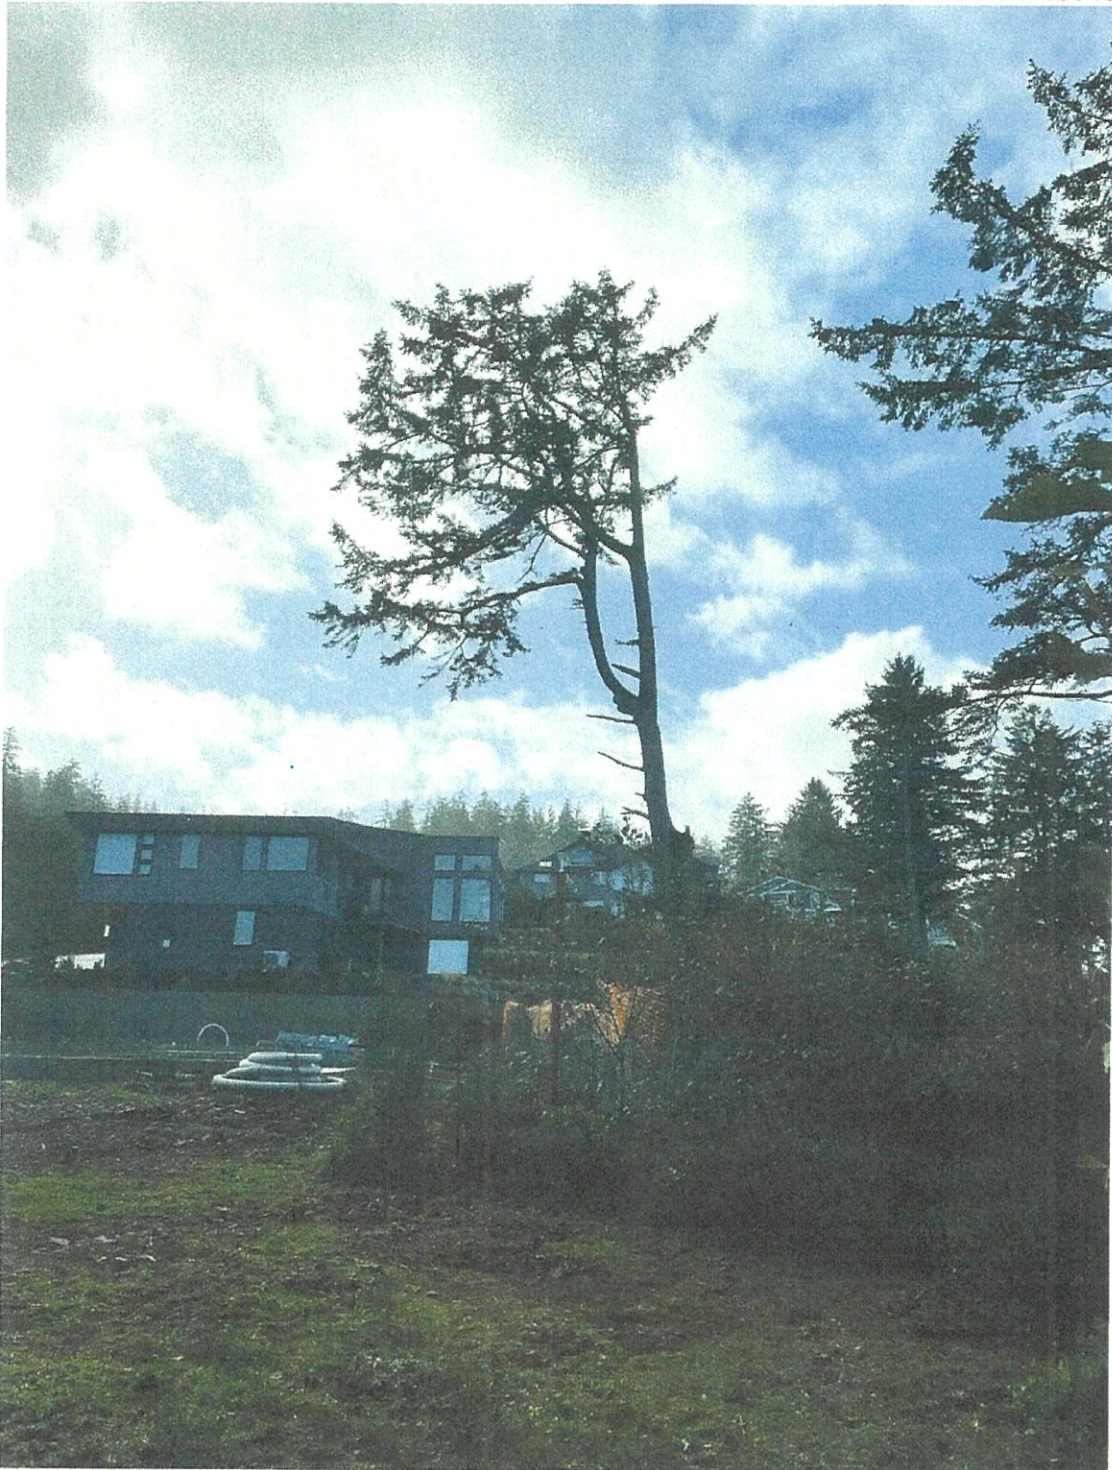
View from the north looking south at the tree with trunk lean, canopy all to east and tip / limb dieback is visible.

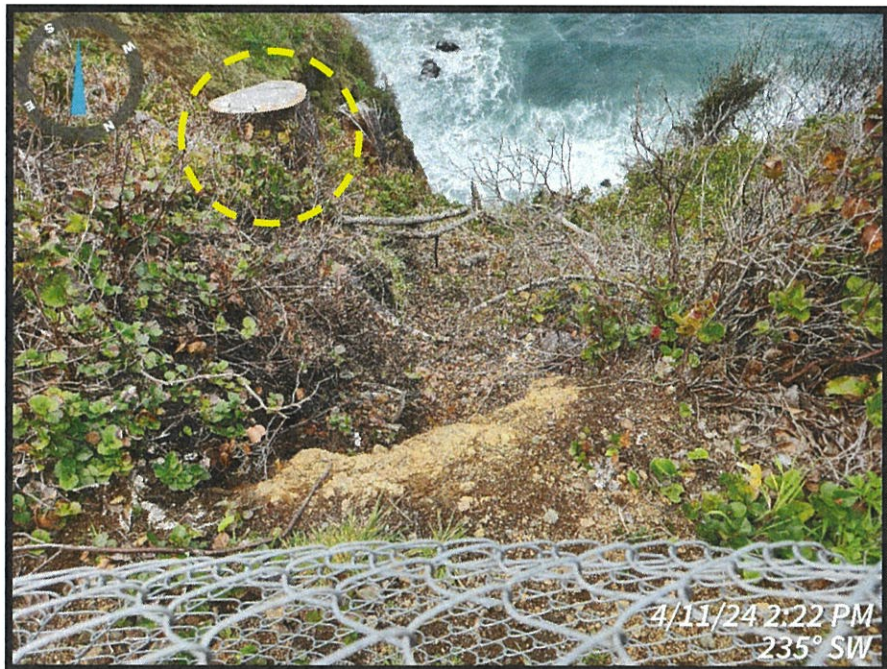
**Photo 3:** View of Sitka stump (yellow dashed circle), looking downslope from the head of the bluff, looking west.

3. We recommend that the stump and root-ball of the removed tree remain. Removal of the root-ball would negatively affect slope stability. The root-ball should maintain soil cohesion and slope stability for the next approximately five years or so, thus allowing for establishment of new root systems as the slope revegetates.

4. We recommend replacing the removed Sitka spruce with new vegetation, specifically with deep-rooted native species, to improve long-term slope stability.

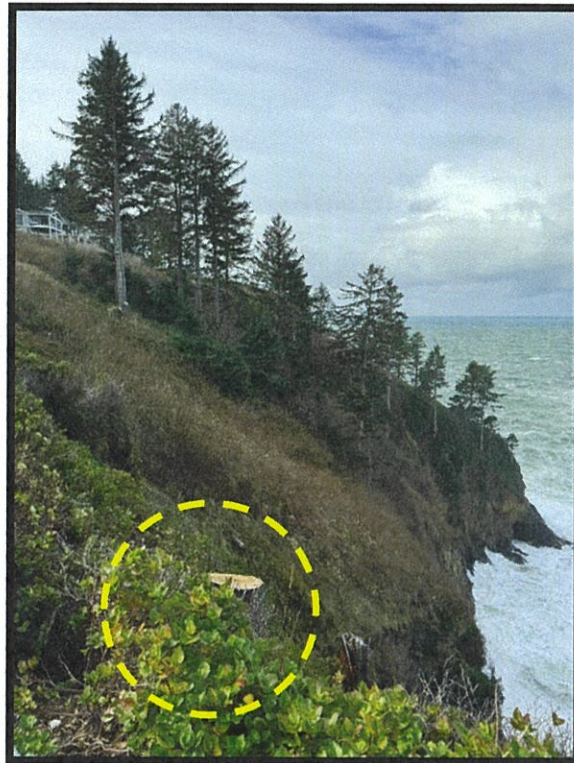
**Photo 4:** View of the stump of the removed Sitka spruce (yellow dashed circle). View is looking south toward the Pacific Ocean.

2. The Arborist report prepared by David D. Hunter noted that the tree before removal was observed to have a 10 percent trunk lean due to the canopy being top heavy (limb dieback) to the east in the direction of the residence currently under construction. Additionally, the tree was observed to have brown butt rot and the stump base was swollen as further evidence of root disease. The arborist also noted that areas nearby have a known history of brown butt rot failures.

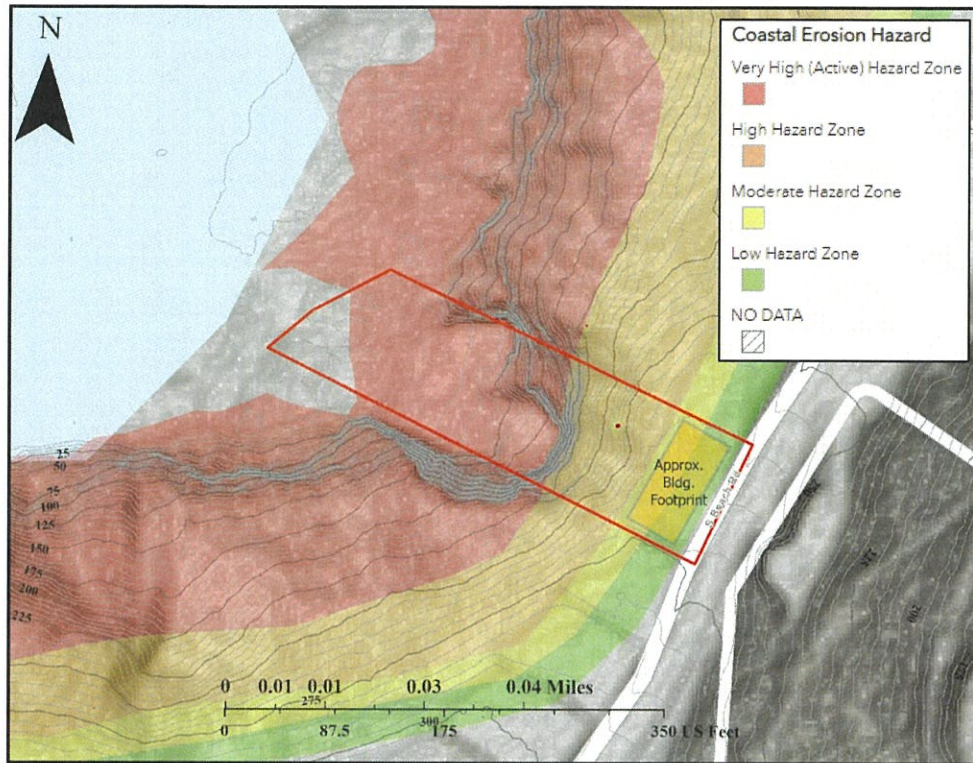
Figure 4: HazVu map showing extent and degree of coastal erosion hazard areas, subject site outlined in red.

We do not consider the site to be in a coastal erosion hazard area since it is located at an elevation of over 260 feet on a headland of dense basalt bedrock. Similarly, we do not consider tsunamis, flooding, and storm surges as hazards for this site.

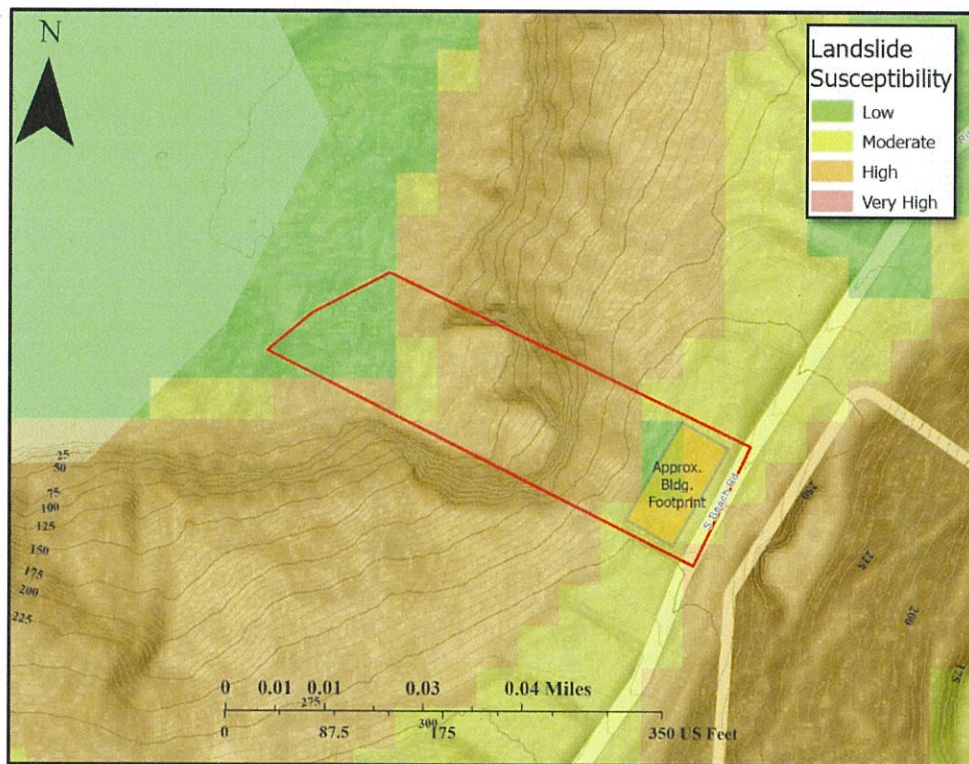
Figure 7: HazVu map showing extent and degree of landslide hazards.

As previously discussed in this report, the site is not mapped on a known landslide, however, there is clear landslide topography on the site along the bluff slope. It is not anticipated that the Sitka spruce removal will increase this risk, assuming geotechnical recommendations in this report are followed.
