Project Pictures

Meda Loop Road Culvert 1708

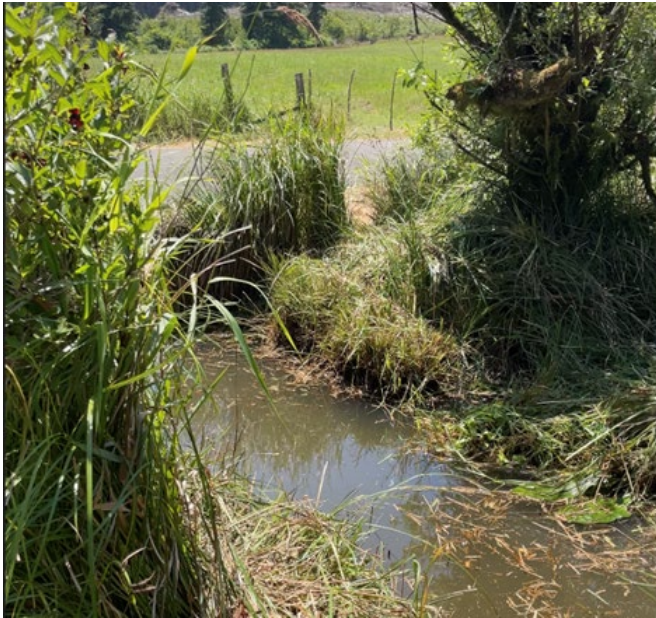
Figure 1: Looking towards outlet

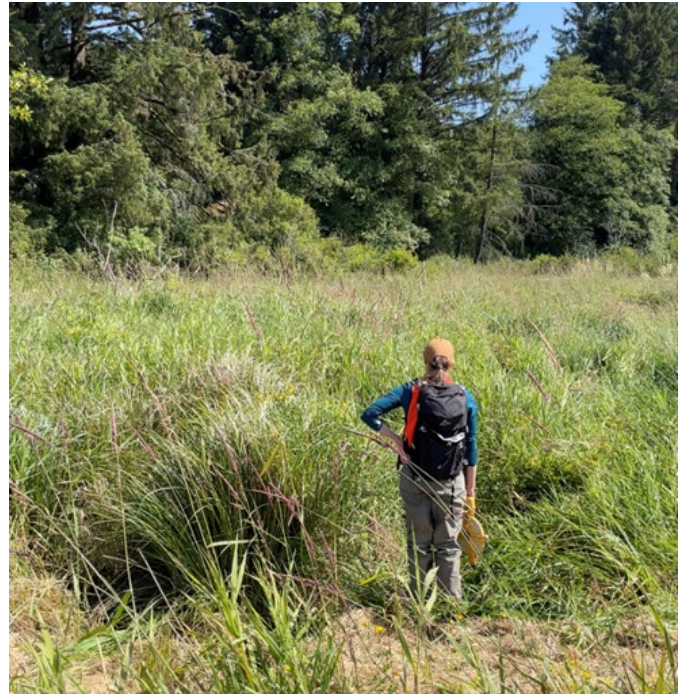
Figure 2: Wetland looking upstream from road

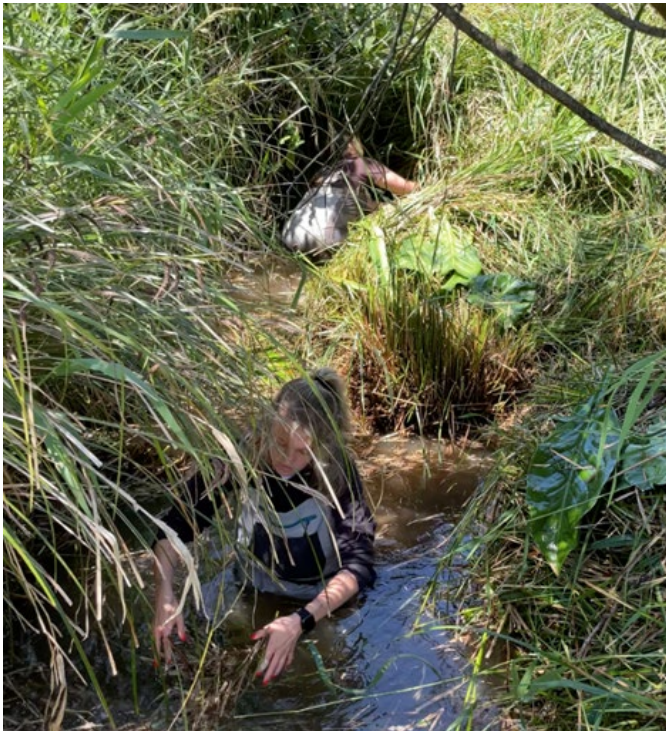
Figure 3: Looking downstream from culvert

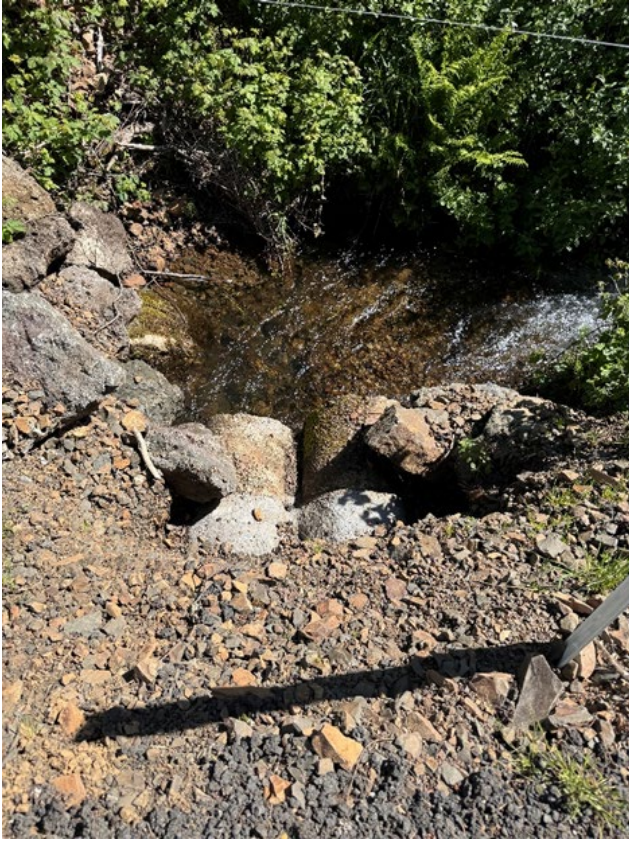
Figure 4: Inlet from top of road

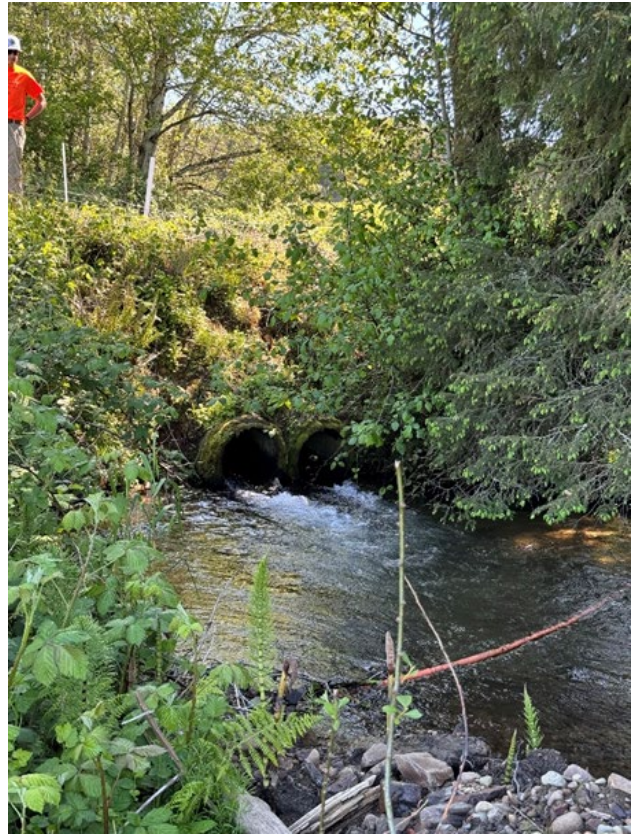
Figure 5: Outlet

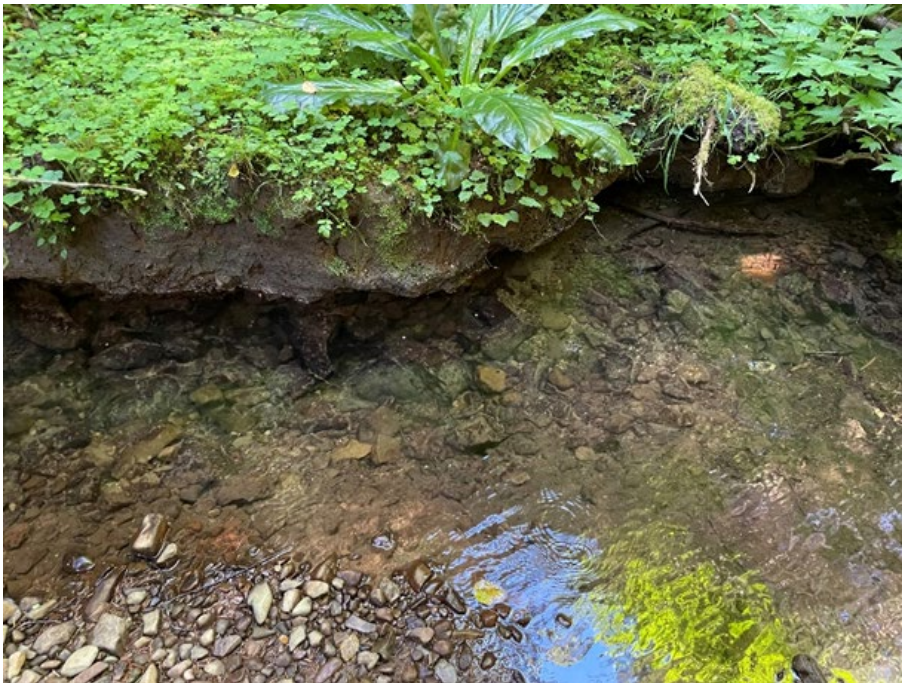
Figure 6: Substrate upstream from culvert

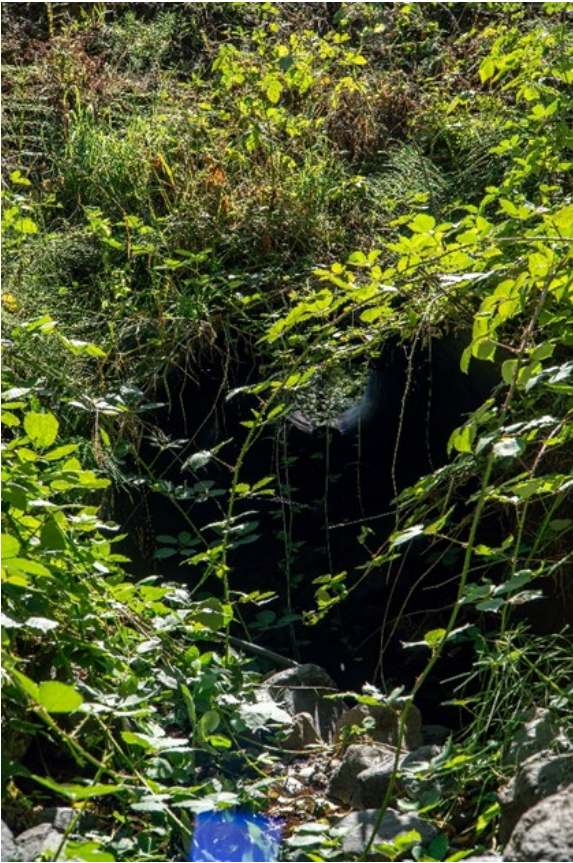
Figure 7: Inlet

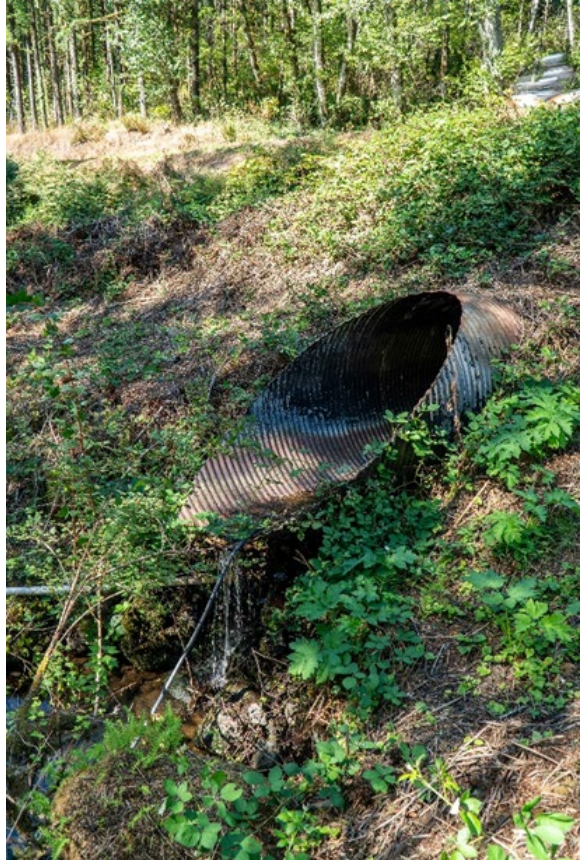
Figure 8: Outlet

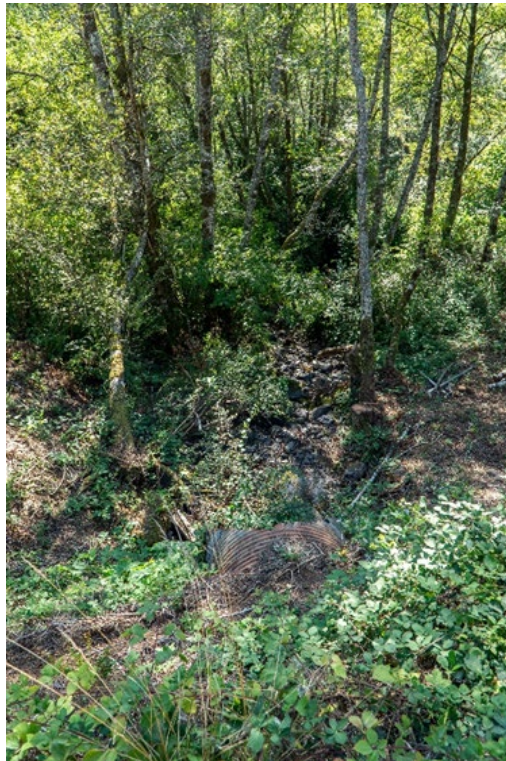
Figure 9: Looking downstream from road

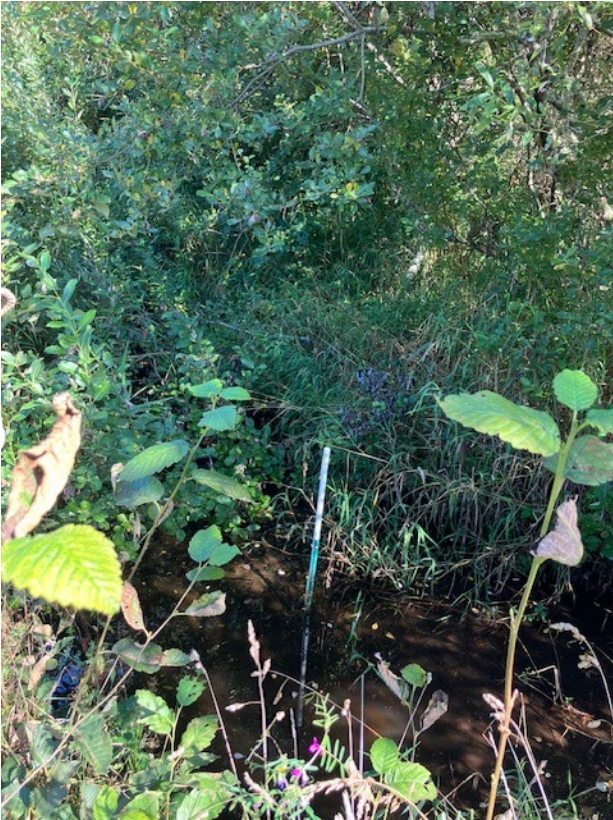
Figure 10: Inlet

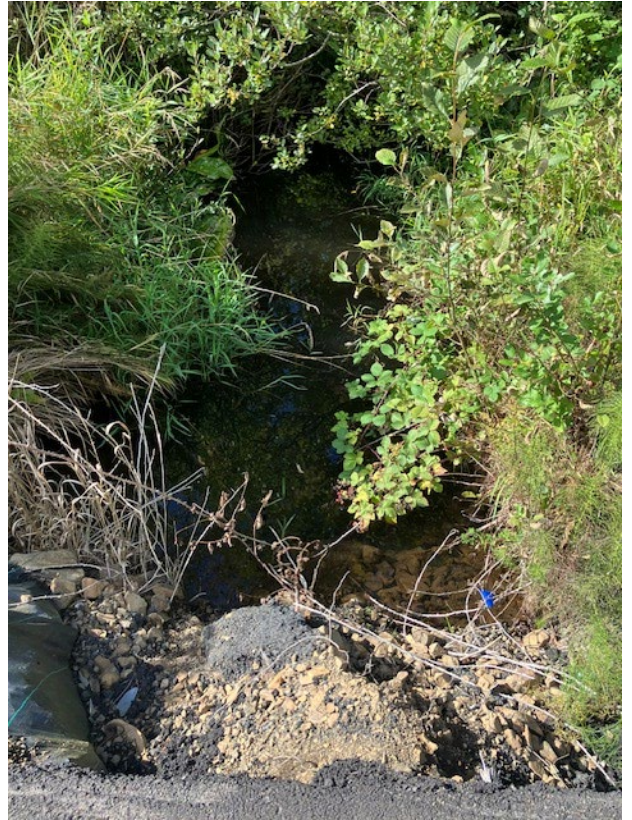
Figure 11: Outlet

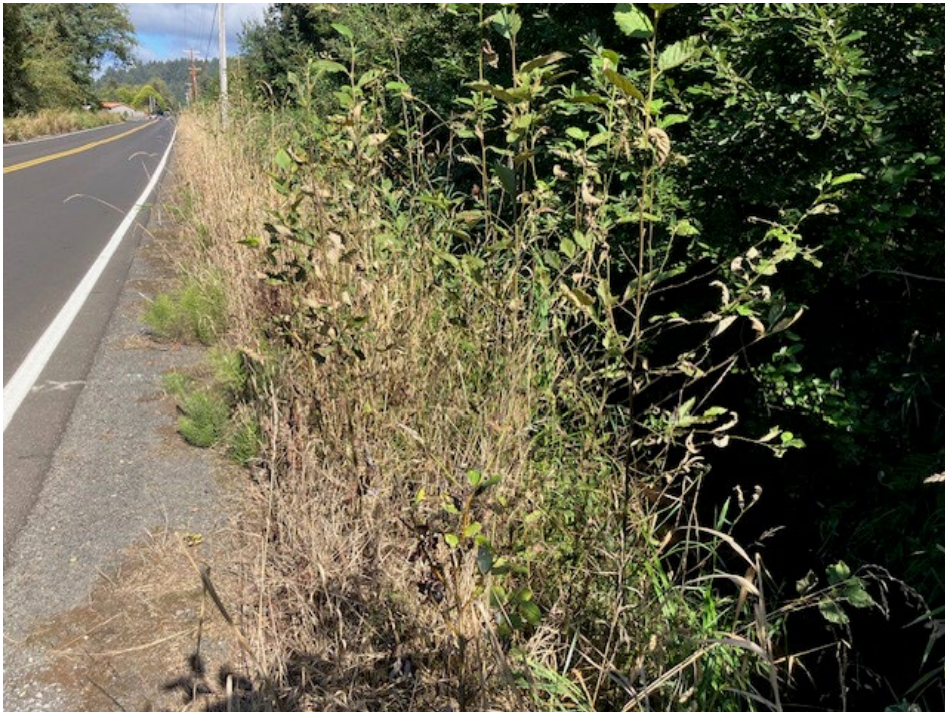
Figure 12: Stream ditched along road
