# NESKOWIN COASTAL HAZARDS AREA PERMIT #851-24-000313-PLNG: Ready2Market/Wells Fargo Bank

**Request:** A request for approval of a Neskowin Coastal Hazard Area Permit for the construction of a

dwelling identified as Unit 11 of the Breakers Condominium, a rebuild of an existing unit

damaged by fire.

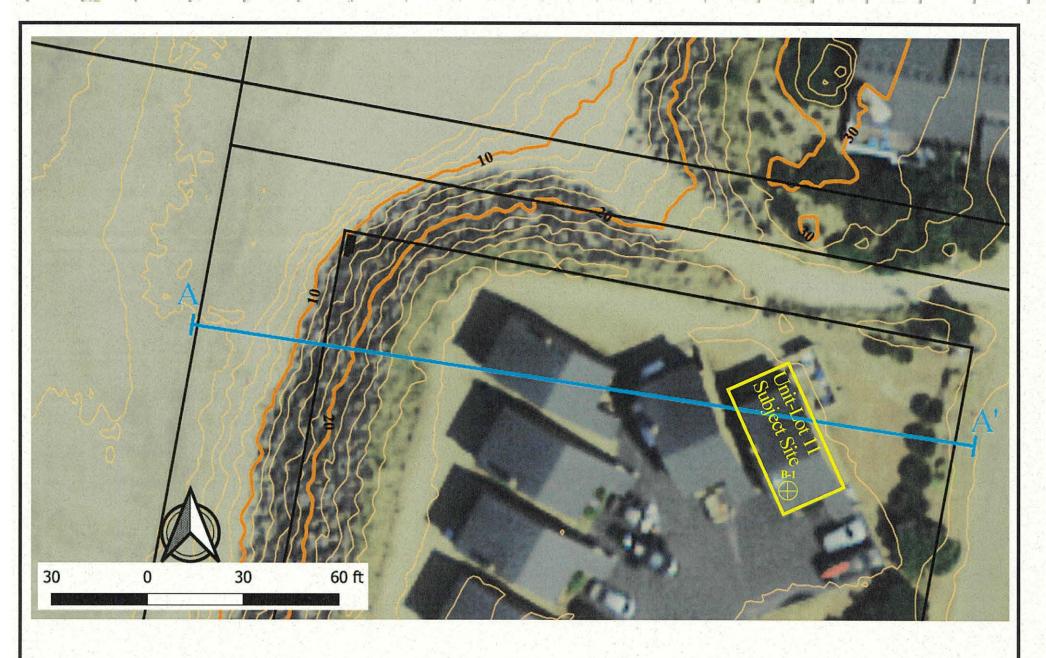
H.G. Schlicker & Associates, Inc. Figure 1

Imagery provided by 2018 Oregon Explorer
Topographic data derived from West\_Coast\_2016\_El\_Nino Lidar data from NOAA
All locations and dimensions are approximate.

= Approximate location of drilled boring

recovered in split spoon samples from Standard Penetration Tests (SPTs) conducted at selected depth intervals to obtain in situ soil strength data based on penetration resistance (blow counts or "N" values). A geologist from our office visually classified and logged the soils encountered in the borehole according to the Unified Soil Classification System (USCS). A detailed description of subsurface conditions encountered during boring is provided in Appendix B, and the approximate location of the borehole is shown on Figures 1 and 2.

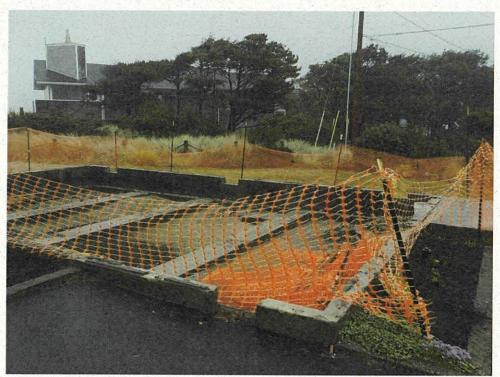
Photo 1 - View of the foundation of the previous house at the site after demolition.

During our previous Geologic Hazards Investigation the site was occupied by a fire-damaged residential structure and attached deck. Since the time of our previous work, the damaged house was demolished, the foundation was removed for equipment access, and a drilling pad was graded using sand (Appendix A). Based on our review of the document provided to us, a surveyor completed an elevation certificate before the demolition of the previous structure.

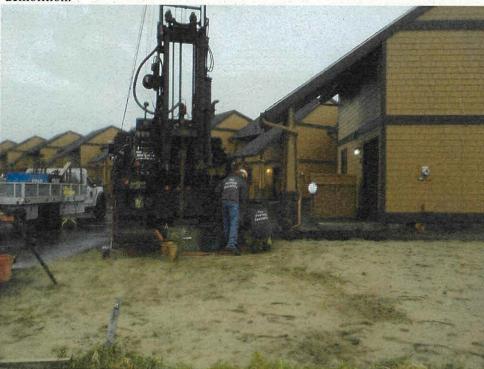
Photo 2 – View of the drill rig set up at the location of Boring B-1.

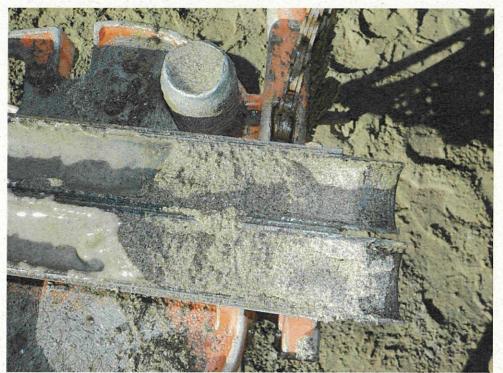
Photo 3 –View of the loose to medium dense, fine-grained sand recovered between 10 to 11.5 feet depth in Boring B-1.

The boring generally encountered approximately 15 feet of loose to medium dense sand overlying approximately 20 feet of wet to saturated, dense sand from approximately 15 to 35 feet, underlain by organic-rich soft silty sand and peat from approximately 35 to 45 feet. From approximately 45 to 60 feet, dense to very dense, wet to saturated sand was encountered. Groundwater was encountered at approximately 12.5 feet.

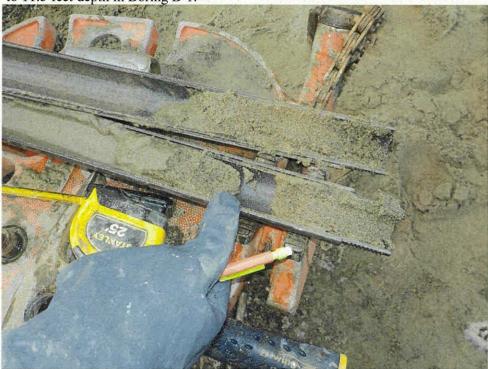
Photo 4 – View of the dense, silty sand recovered between 25 to 26.5 feet depth in Boring B-1.

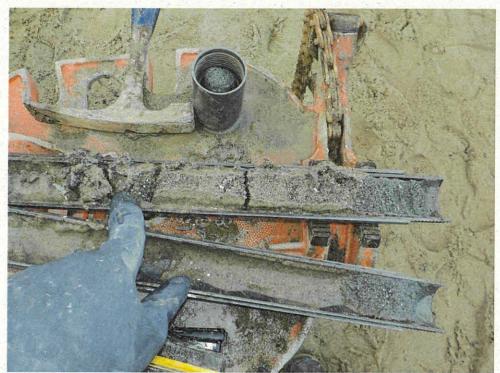
Photo 5 – View of the dense, medium to coarse-grained sand with shell fragments recovered between 30 to 31.5 feet depth in Boring B-1.

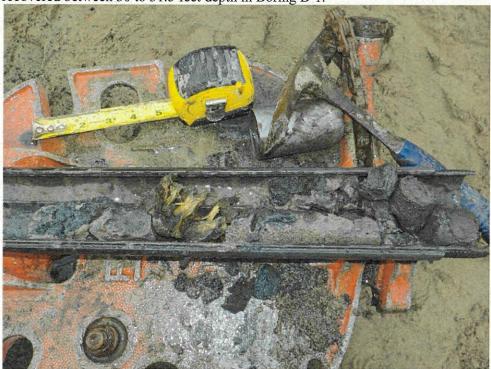
Photo 6 – View of the soft/loose, clayey, silty sand with decaying wood fragments recovered between 37 to 38.5 feet depth in Boring B-1.

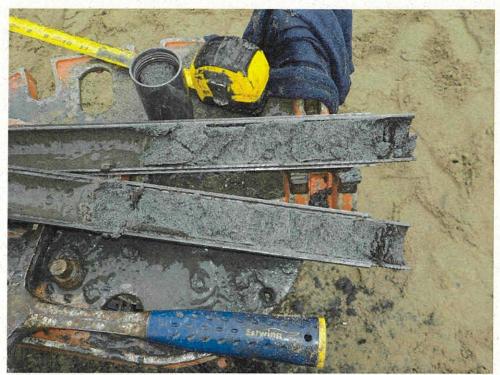
Photo 7 – View of the very dense silty sand with decaying wood fragments recovered between 50 to 51.5 feet depth in Boring B-1.

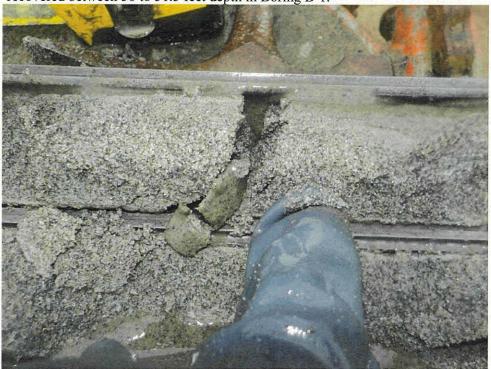
Photo 8 – Close-up view of the very dense, fine-grained, clean sand recovered between 60 to 61.5 feet depth in Boring B-1.

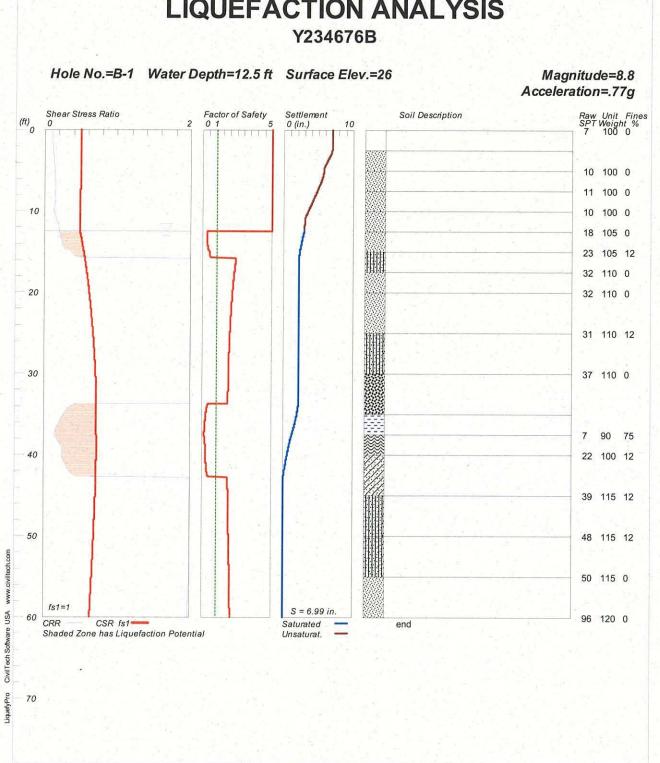
# LIQUEFACTION ANALYSIS

To determine the liquefaction potential of the site, we used the computer program LiquefyPro by CivilTech Software, which utilizes methods recommended by the 1996 NCEER Workshop to calculate liquefaction and seismic-induced settlement potential (Martin et al., 1999) (Appendix C).

Based on our analysis, the total amount of earthquake-induced liquefaction and volumetric compression is estimated at approximately 6.99 inches, and differential settlements can be expected to be as much as  $^{1}/_{2}$  to  $^{2}/_{3}$  of the total or approximately 3.5 to 4.7 inches (Appendix C). Because this settlement occurs above the recommended pile tip embedment depth, we would expect little to no settlement of a house founded on the recommended pile below.

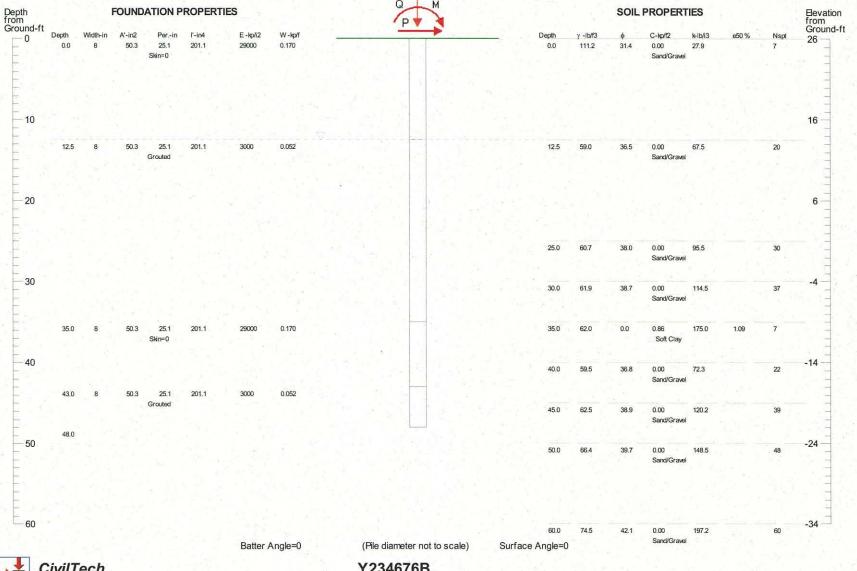
### **FOUNDATION PROFILE & SOIL CONDITIONS**

For uplift and compression, one no-friction steel casing section and one high pressure grouted section.

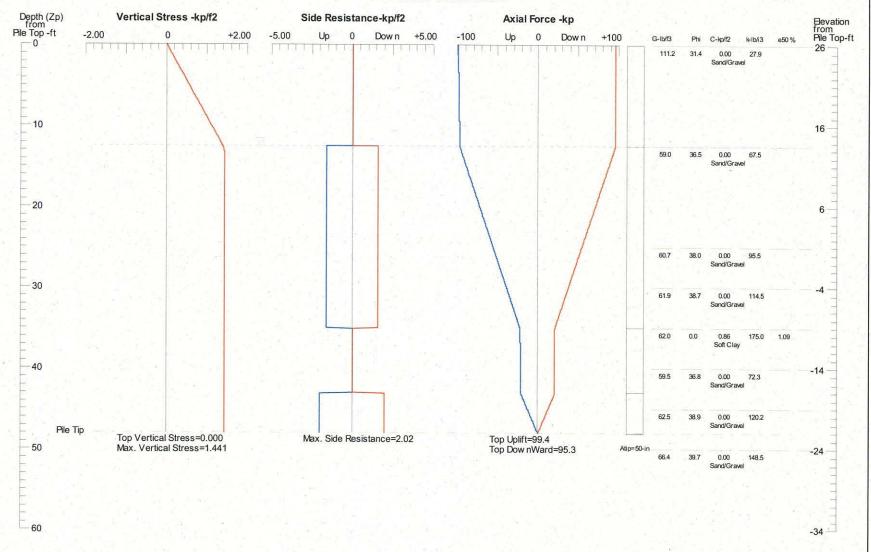
# SOIL STRESS, SIDE RESISTANCE, & AXIAL FORCE vs DEPTH Based on Ultimate Load Condition

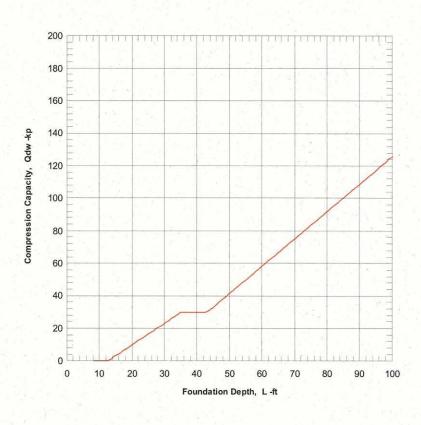
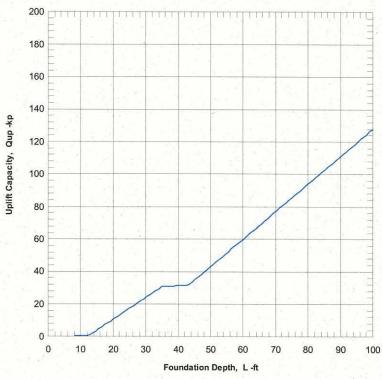
# **ALLOWABLE CAPACITY vs FOUNDATION DEPTH**

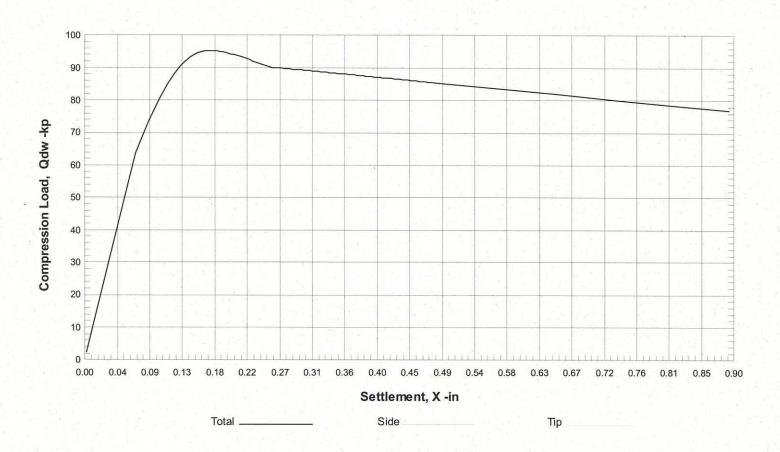
# Vertical Load vs. Settlement

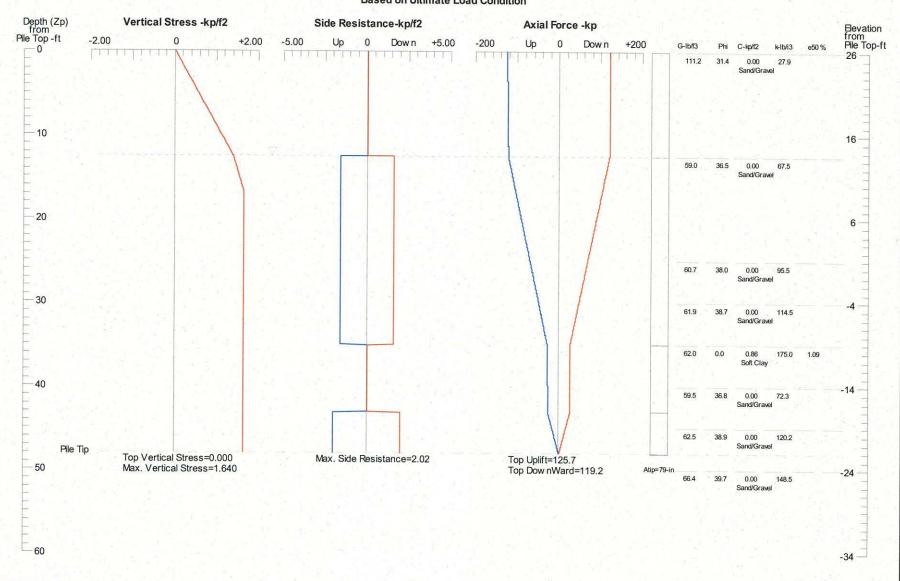
# SOIL STRESS, SIDE RESISTANCE, & AXIAL FORCE vs DEPTH Based on Ultimate Load Condition

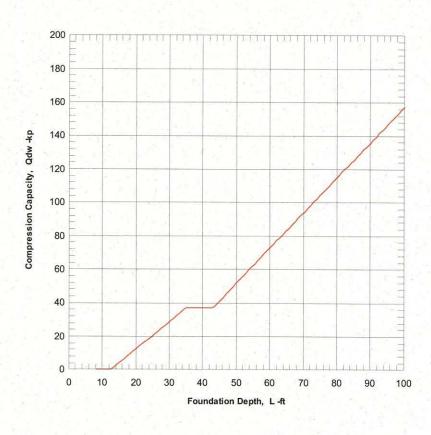
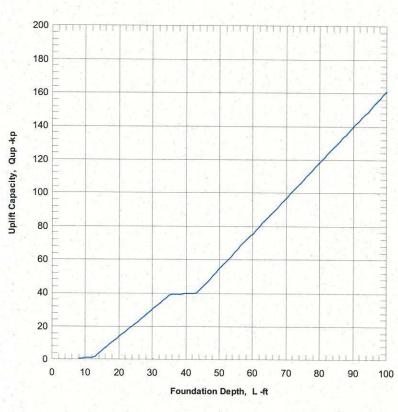
# **ALLOWABLE CAPACITY vs FOUNDATION DEPTH**

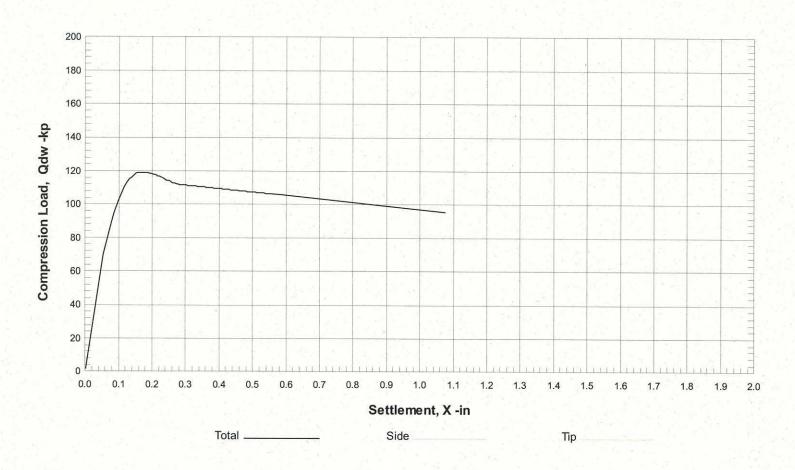
# Vertical Load vs. Settlement

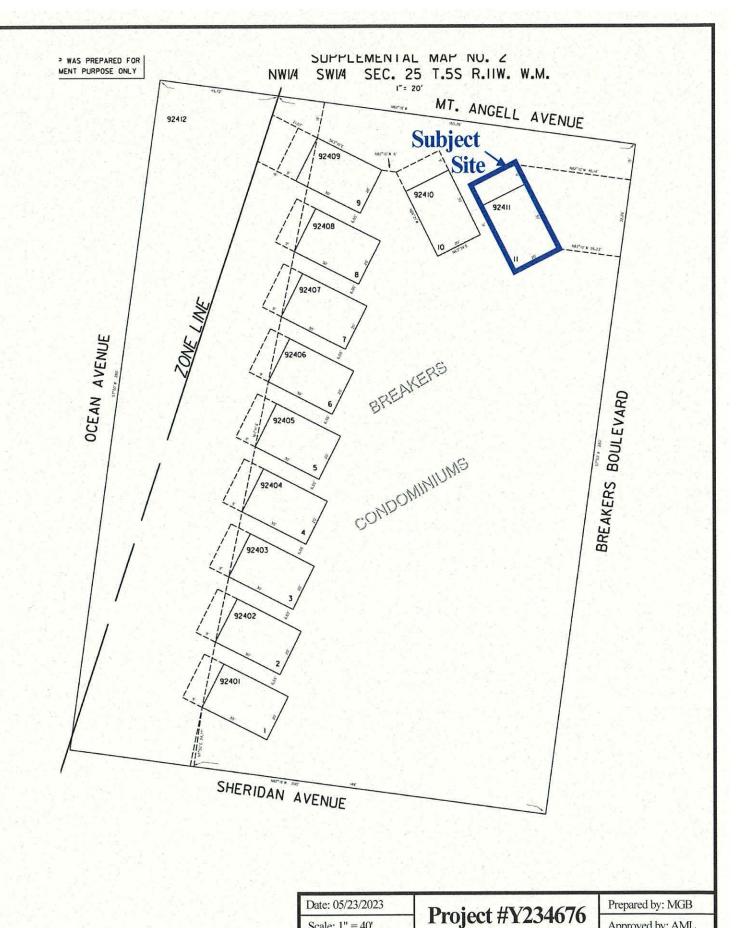
Figure 2

Tax Lot 92411, Map 5S-11W-25CB Supp. Map No. 2 Lot-Unit 11, 48060 Breakers Blvd, Neskowin, Tillamook County, Oregon

Modified from the Tillamook County assessor's plat 5S-11W-25CB Supp. No. 2 All locations and dimensions are approximate.

younger stabilized dune at the Breakers Condominiums in the community of Neskowin, Oregon (Figure 1). The site is one of eleven condominium tax lots located within Tax Lot 92412, Map 5S-11W-25CB, which encompasses the greater area of the Breakers Condominiums (Figure 2).

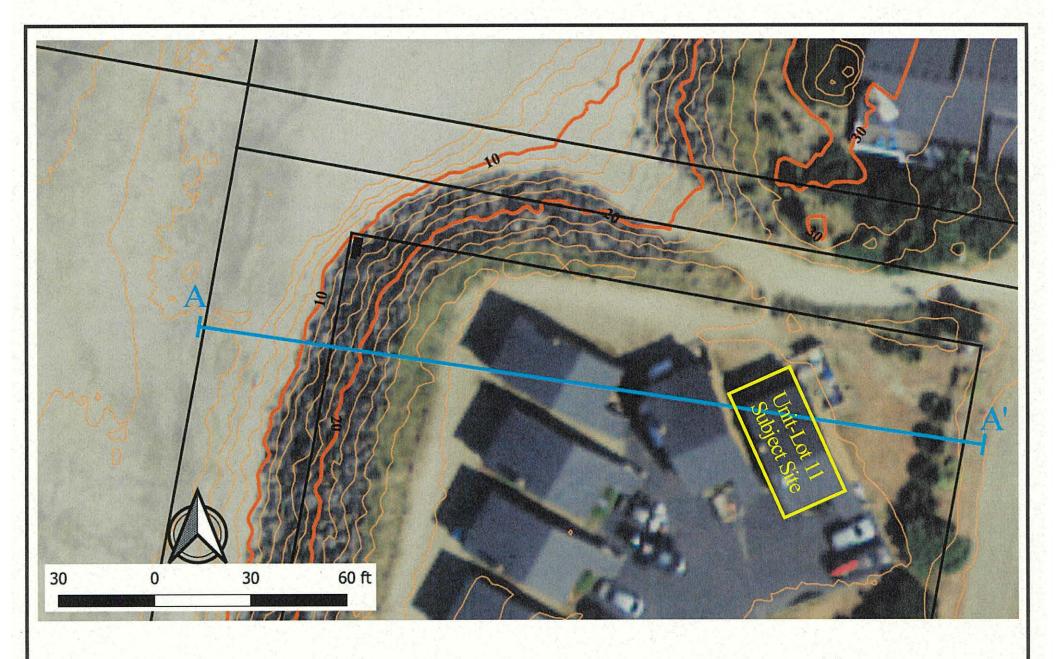
H.G. Schlicker & Associates, Inc. Figure 3

Imagery provided by 2018 Oregon Explorer
Topographic data derived from West\_Coast\_2016\_El\_Nino Lidar data from NOAA
All locations and dimensions are approximate.

= Approximate trend of profile line

The site is located on the western portion of a younger stabilized dune. Elevation at the site is approximately 26 feet (NAVD 88). The area of the site is generally flat but appears to have been subject to prior grading activities (Figures 3 and 4; Appendix A).

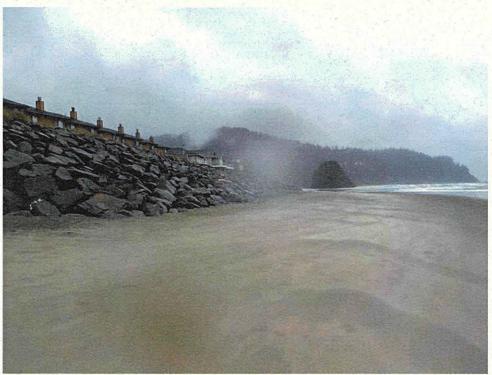
Photo 6 – Southerly view of the beach and rip rap revetment west of the site.

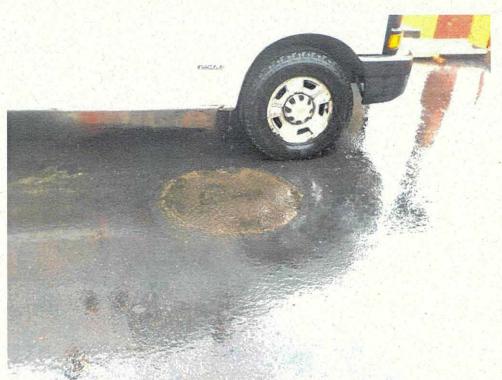
Photo 8 – Close-up view of a manhole near the site indicating the potential presence of buried private utilities and installations.
