NESKOWIN COASTAL HAZARDS AREA PERMIT
#851-24-000098-PLNG: ALFONSO & WOMBWELL TREE REMOVAL

Request: Approval of a Neskowin Coastal Hazard Area Permit for the removal of a tree.

NESKOWIN COASTAL HAZARD AREA PERMIT REQUEST
#851-24-000098-PLNG: ALFONSO & WOMBWELL
ADMINISTRATIVE DECISION & STAFF REPORT

4. Development of this property shall adhere to the development recommendations outlined in the Geotechnical Visual Reconnaissance (GHR) prepared by Carson Rittel, RG, and Adam Reese, CEG, RG, Earth Engineers Inc., dated February 4, 2024, and amended May 1, 2024, for tree removal (Exhibit B), including the following:

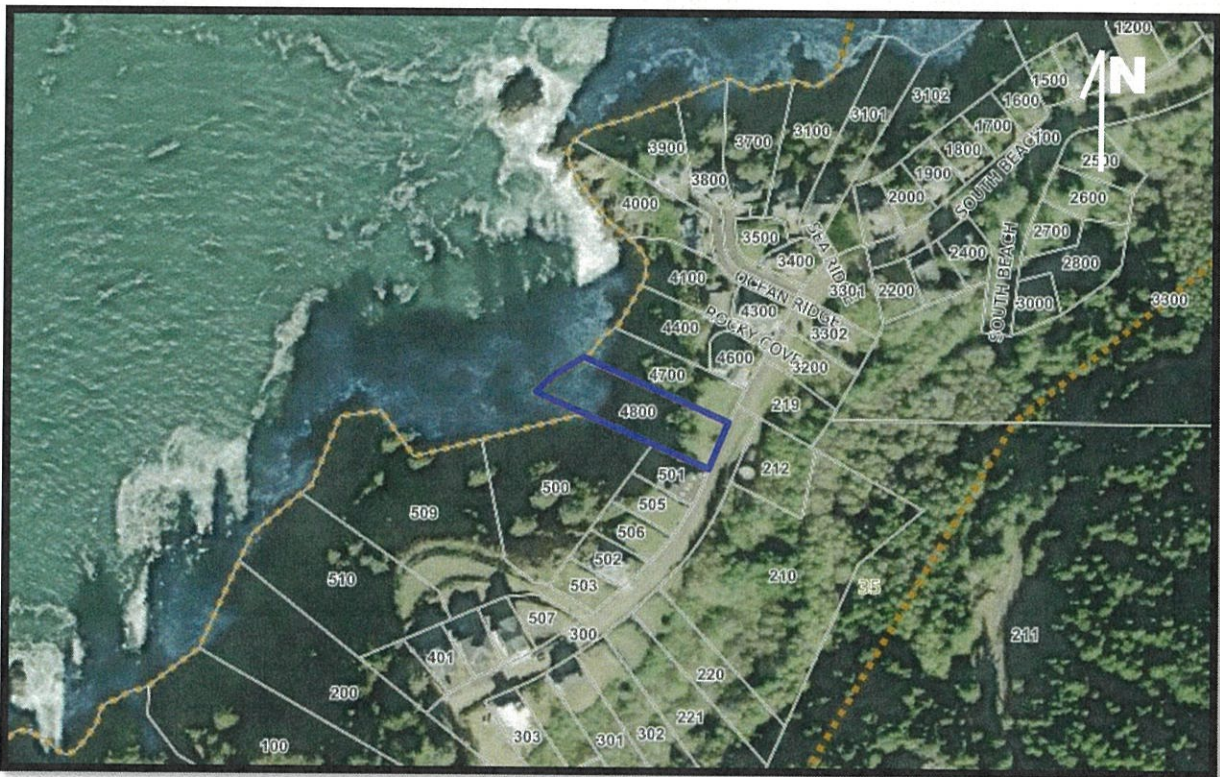
The project site is located at Tax Lot 4800 (Map 5S-11-35 DA) along South Beach Road in Neskowin, Tillamook County, Oregon. The property is oceanfront, and sits atop of a sea cliff approximately one mile south of Neskowin. The property location relative to surrounding features is provided in Figure 1 below.

The 0.81-acre property is generally rectangular in shape (approximately 100 feet wide by 350 feet long) and is bordered by South Beach Road to the east, residential properties to the north and south, and the Pacific Ocean the west, as shown below in Figure 1.

Figure 1: Property location, outlined in blue (base image source: <http://tillamookcountymaps.co.tillamook.or.us/>).

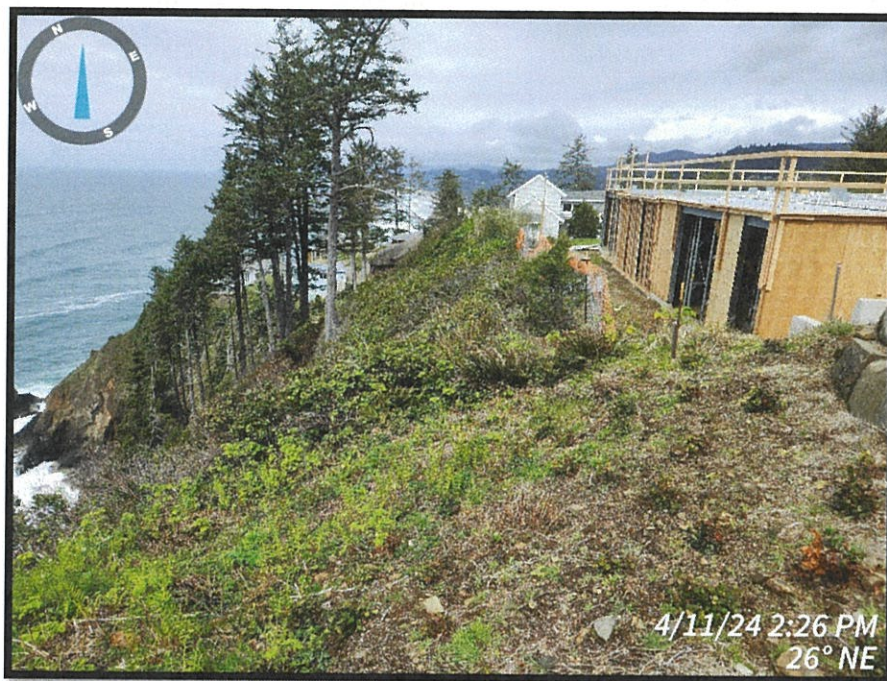
Photo 2: Recent conditions of the subject property, viewed from southwest looking north-northeast.

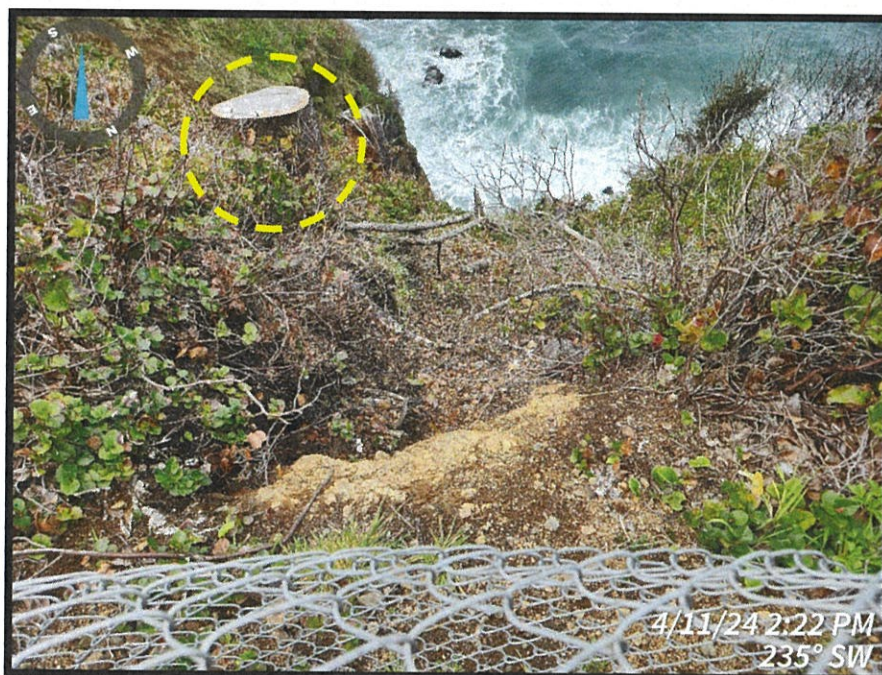
Photo 3: View of Sitka stump (yellow dashed circle), looking downslope from the head of the bluff, looking west.

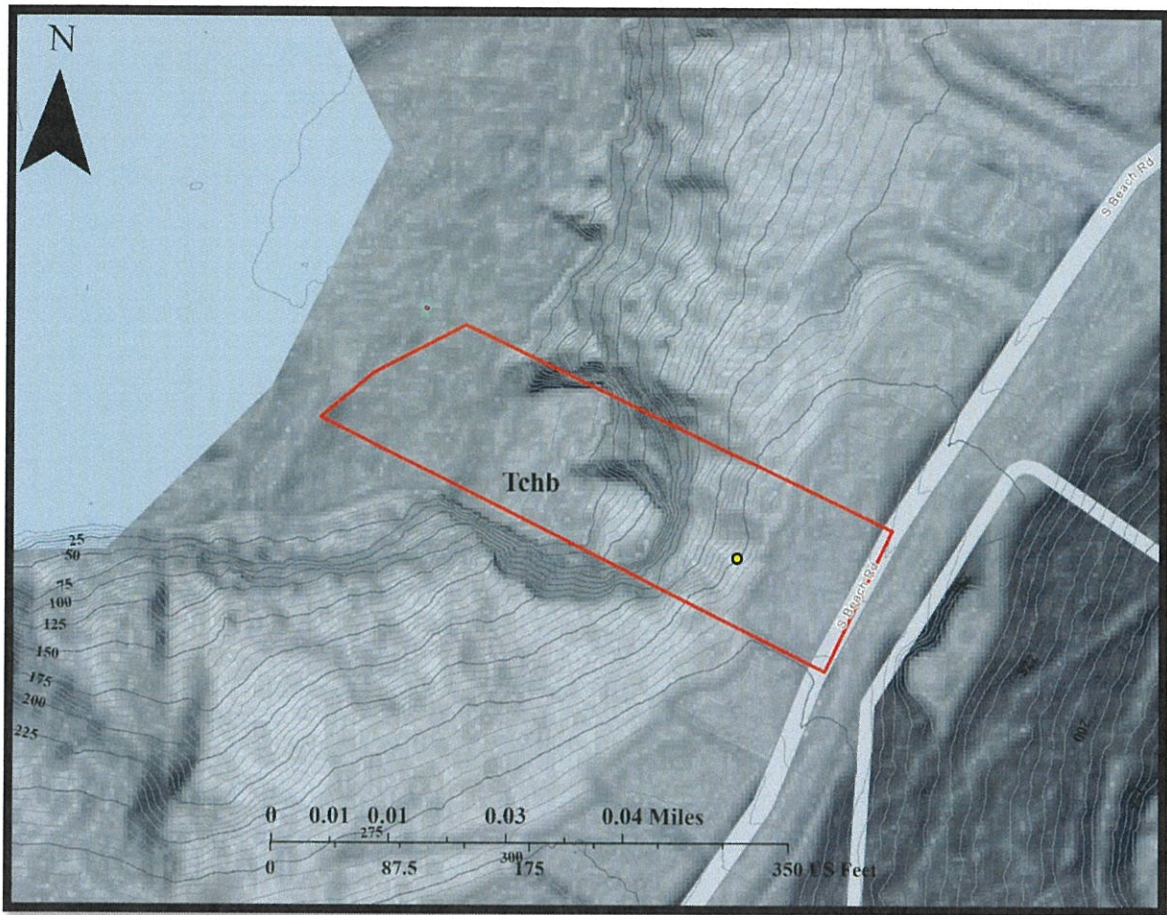
Figure 3: Geologic map of the area (source: DOGAMI OGDC-7). Subject tax lot outlined in red; approximate location of Sitka Spruce notated as a yellow point; Tchb: Tertiary Basalt of Cascade Head; Contour interval = 5 feet

The project area was mapped by Snavely, Macleod and Minasian (1990) of the U.S. Geological Survey to include the bedrock units of Tchb-Basalt of Cascade Head (Upper Eocene)². The Basalt of Cascade Head is described as subaerial flows of massive to platy basalt that is locally very vesicular. See Figure 3 below for the geologic map of the site location, as currently mapped by the DOGAMI Oregon Geologic Database Compilation 7 (McCloughrey et al. 2023).

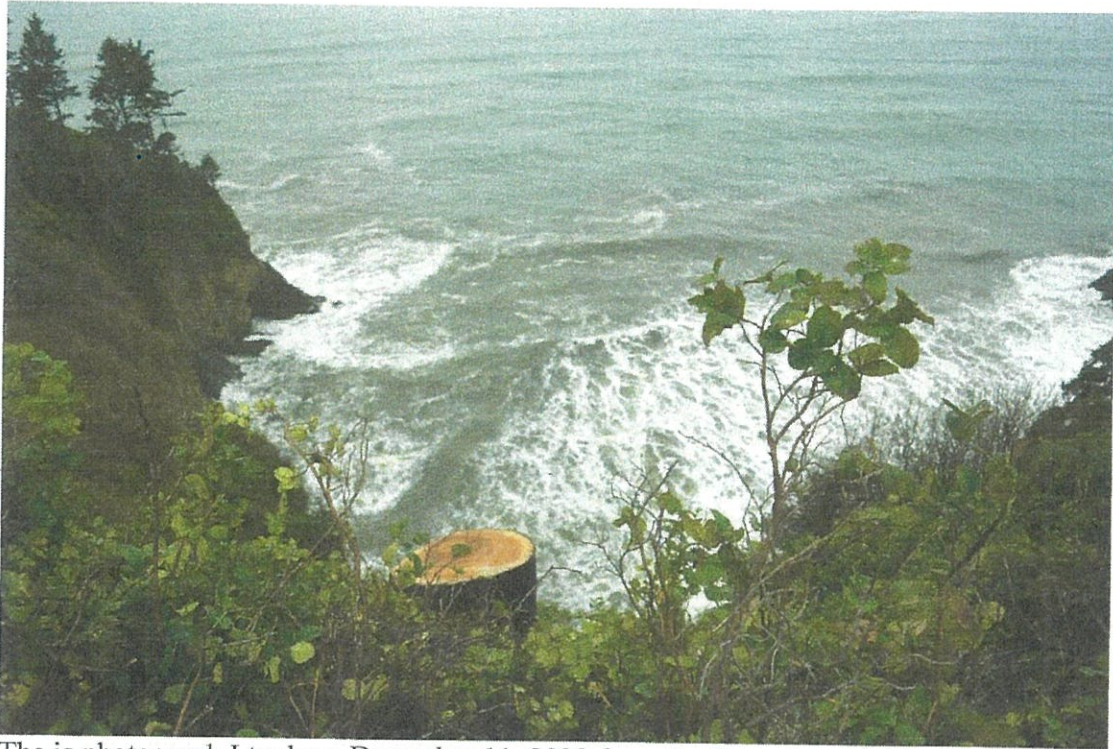
The is photograph I took on December 11, 2023 from the fence line edge looking over the edge at the tree stump. Stump is 20' down slope. To right is open space where tree was prior but failed and took surrounding soil and tree to ocean. The stump at least remains and will hold the soil and slope for many years till the roots rot out.

Looking at the stump the center and to the left of the salal leaf the stump wood is off-colored and darker color which is a sign of brown butt rot. The stump base was also swollen as another sign to the root disease.

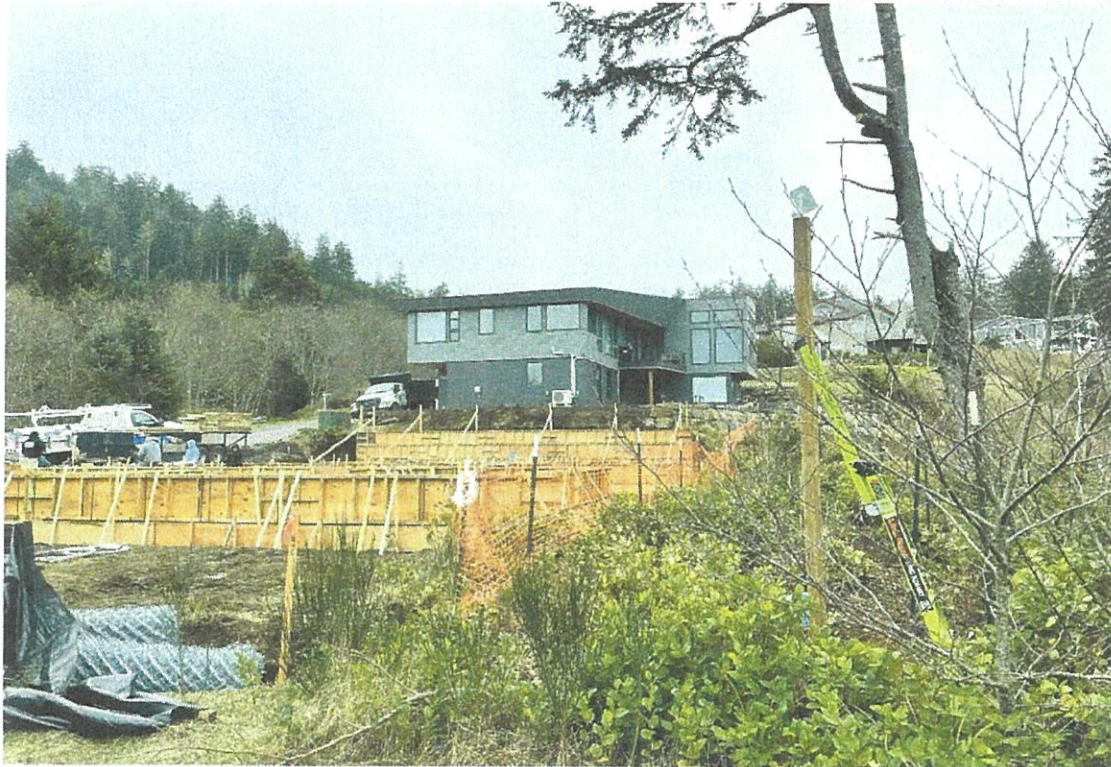
View of the tree from the north, trunk lean is east, limb weight is east. Had to have been other trees to the west that failed and are no longer there.

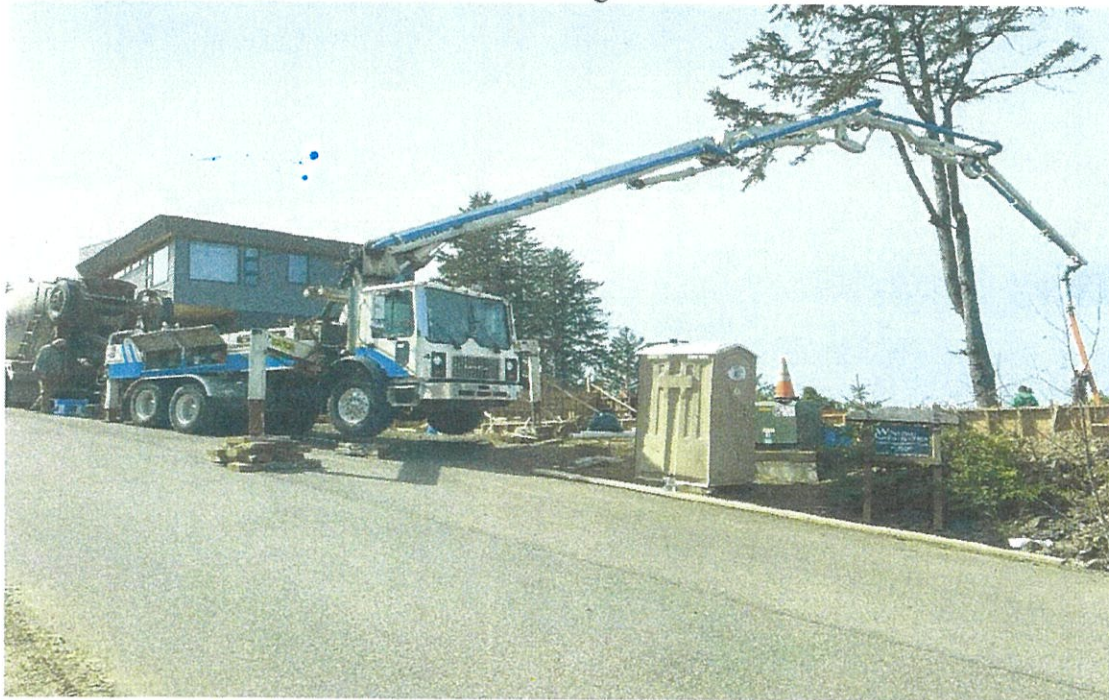
View of the tree from road trunk lean, limb dieback, crown top heavy.

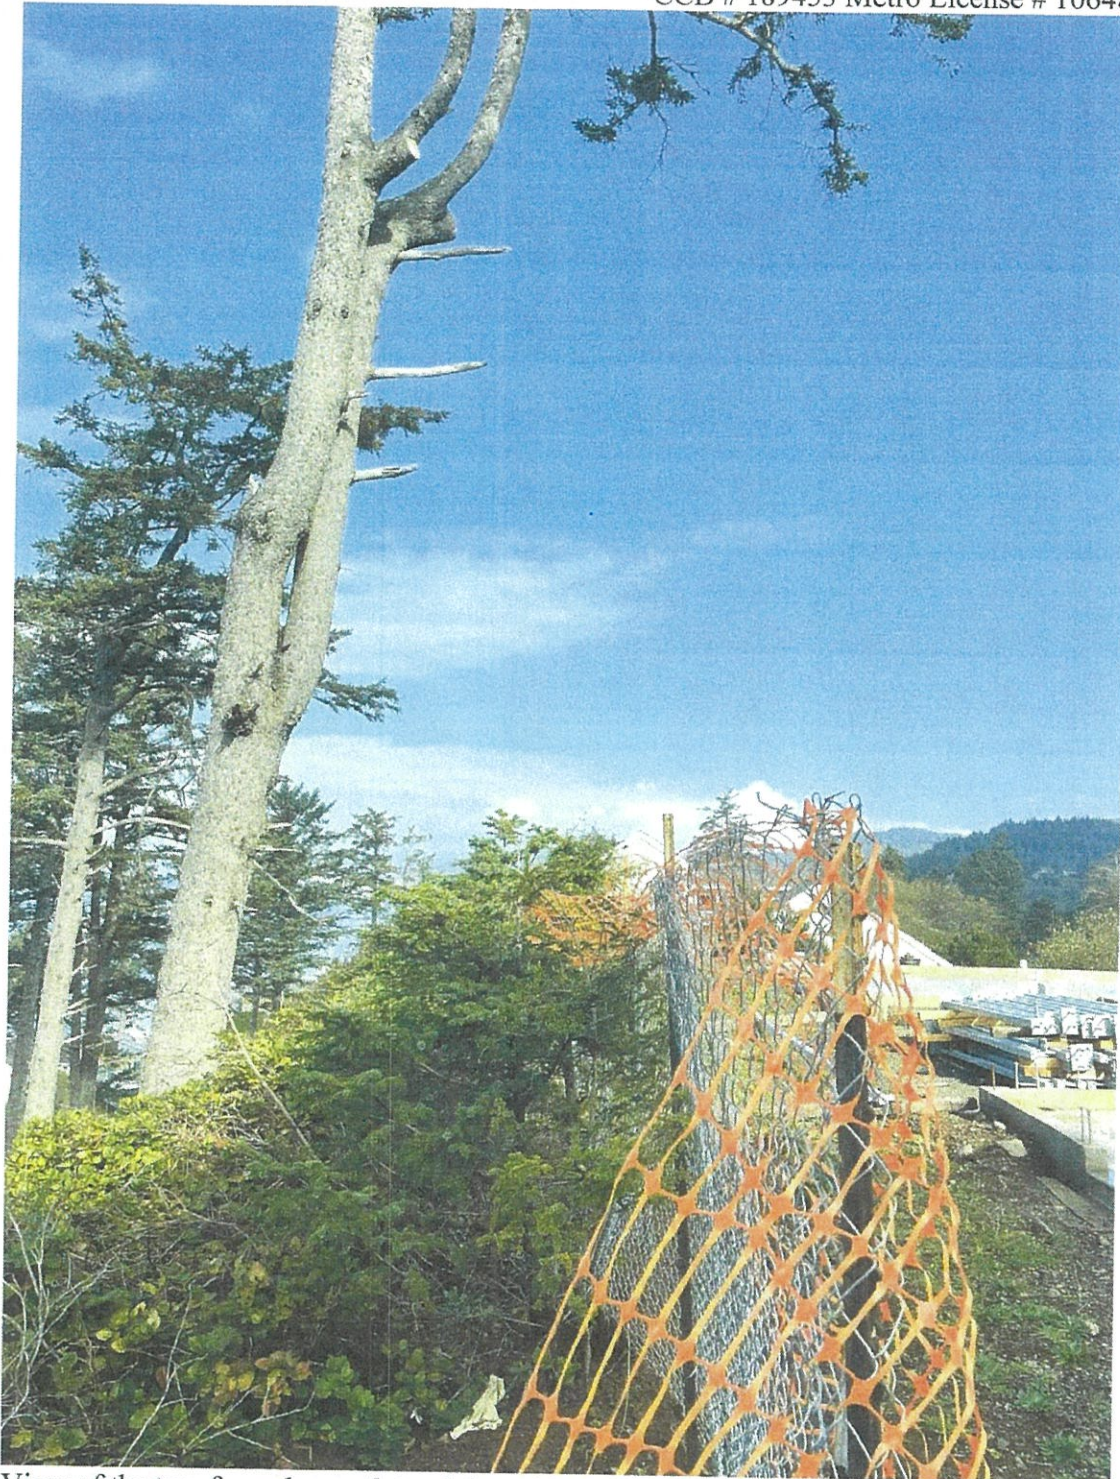
View of the tree from the south trunk lean 10 percent, prior defect left stem mid stem left with the white knob on the left.

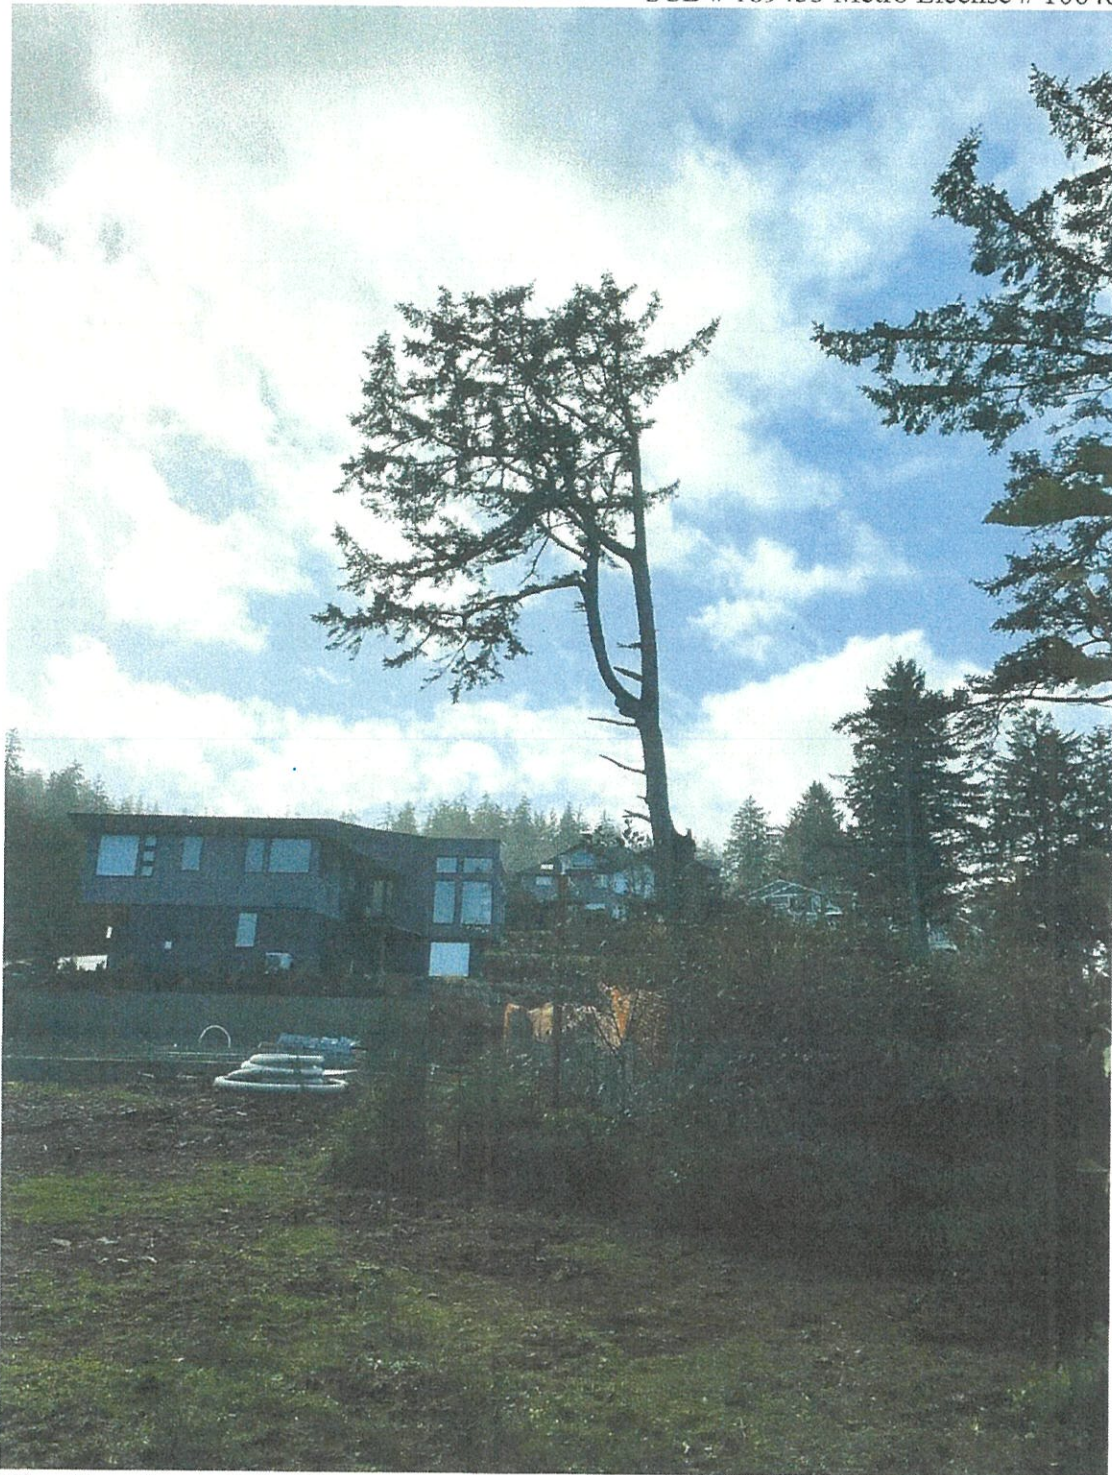
View from the north looking south at the tree with trunk lean, canopy all to east and tip / limb dieback is visible.

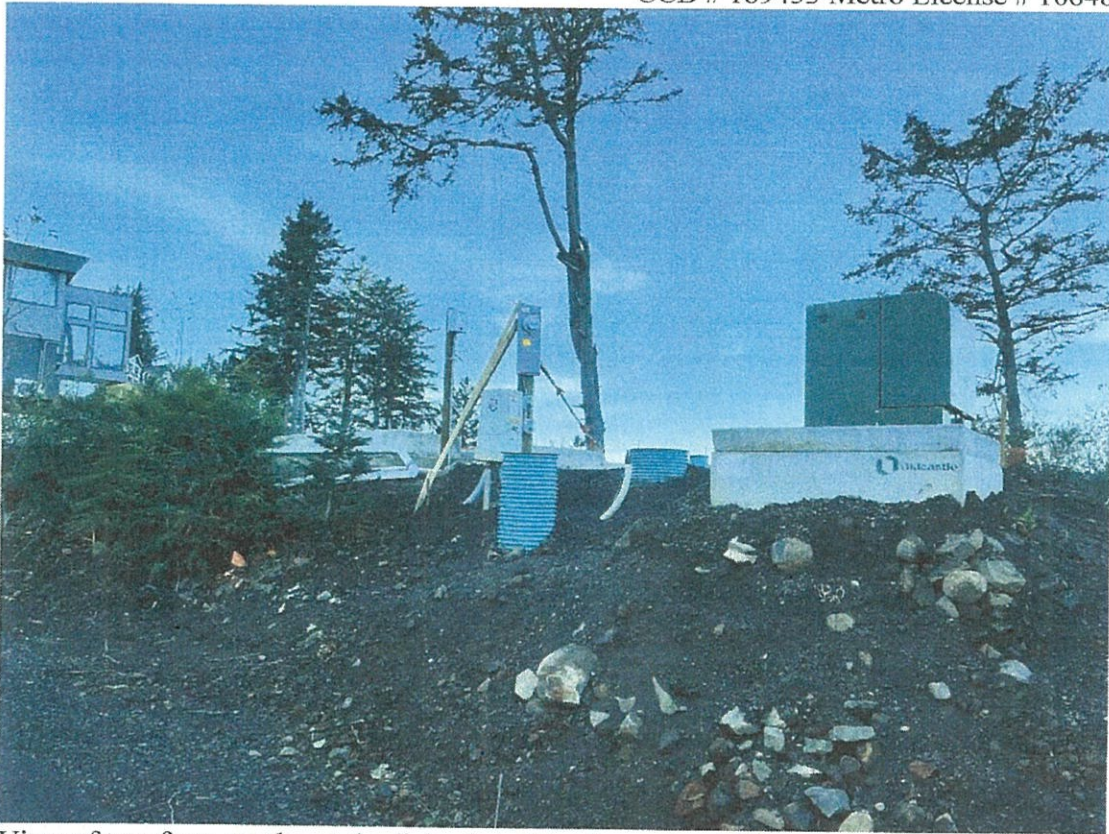
View of tree from northeast tip dieback and top heavy is visible.
