OREGON PUBLIC LAND CORNER REPORT / RESTORATION REPORT  
Tillamook County Surveyor's Office

<b>CORNER DESIGNATION:</b> Section corner common to Section 36, T5S, R11W; Section 31, T5S, R10W; W.M.,	<b>(Please check one)</b>	
	<input type="checkbox"/>	Condition Report Only
	<input checked="" type="checkbox"/>	Restoration
	<input type="checkbox"/>	Rewitness
	<input type="checkbox"/>	Unrecorded
	<input checked="" type="checkbox"/>	Reset at surface
	<input type="checkbox"/>	Referenced Out

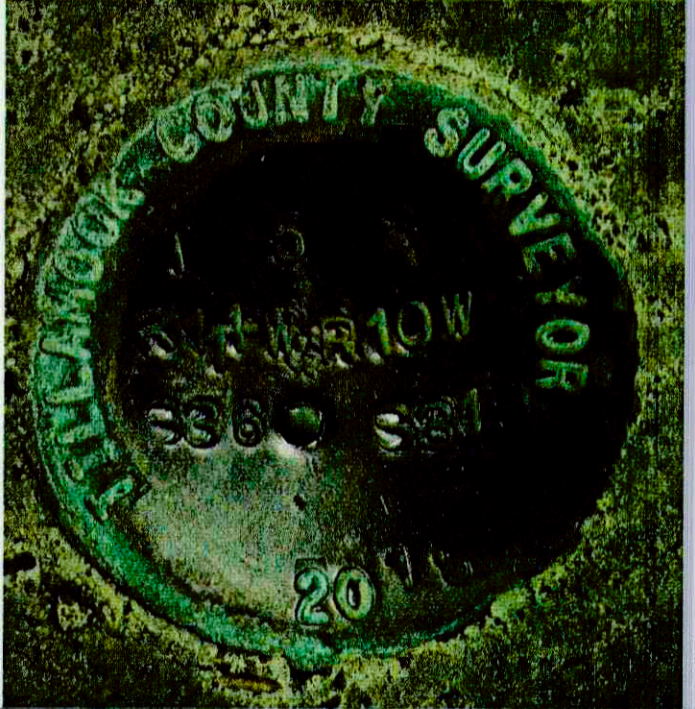
Picture of Set Monument:

**Monument Set (Procedures and Description):** Set a 2" diameter brass cap stamped "T5S R11W R10W S36 S31 2015" in concrete at road surface. We referenced the found 3-1/4" BLM brass cap by setting rock nails in the existing asphalt pavement.
